Acoustic emission description from a damage and failure scenario of rotomoulded polyolefin sandwich structure subjected to internal pressure for storage applications

Eric Lainé^{1,*}, Jean-Claude Grandidier¹, Maxime Cruz¹, Anne-Laure Gorge¹, Claire Bouvy², and Geert Vaes²

¹ Institut Pprime, CNRS, ISAE-ENSMA, Université de Poitiers, 86962 Futuroscope, France

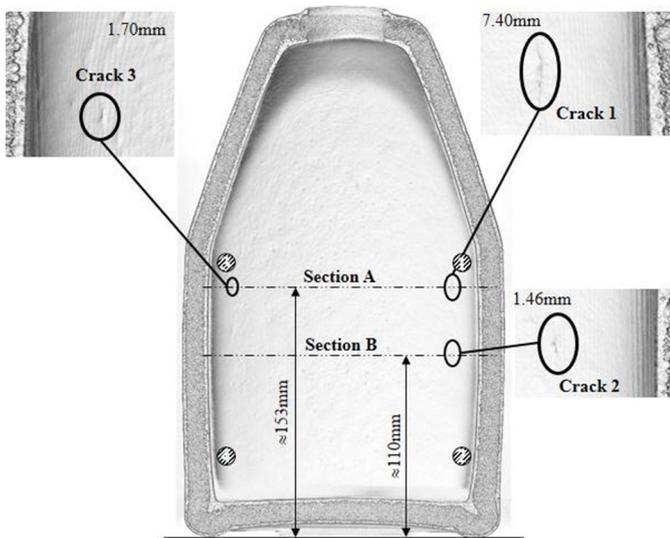
Fig. 14. Test 1. Bottle – location of rupture zone.

An analysis of acoustic emission suggests that they are located between the sensor pairs 1-2 and 3-4, and very close to sensors 1 and 3. The tomography images of this area show that the inner skin of the bottle is beginning to damage itself (Figs. 14 and 15). A small crack has appeared in an area where the skin thickness is very thin, next to initial cavities at the skin/foam interface (Fig. 14). It is important to note that not all thinner areas are subject to this level of load damage. The first damage appeared near the bottom curvature, it is a more complex stress area than the bottle walls. No local breakage is observed on the opposite side (sensors from 5 to 8). The 20 hits captured during this test are distributed on the two sensors 1 and 3, respectively, 16 and 4 hits. Locally measured cracks are 7.4 mm for crack 1 and 1.7 mm for crack 3. It is very likely that crack 2 between sensors 1 and 3 is not captured. If a link can be made between the number of hits and the length of a crack, then we see that here the ratios are very similar, so this ratio is 0.463 for crack 1 and 0.425 for crack 3. Figure 13b shows that the signature of these hits are very close to those observed in the damage phase of the specimen in traction. All points are above the slope line 20.

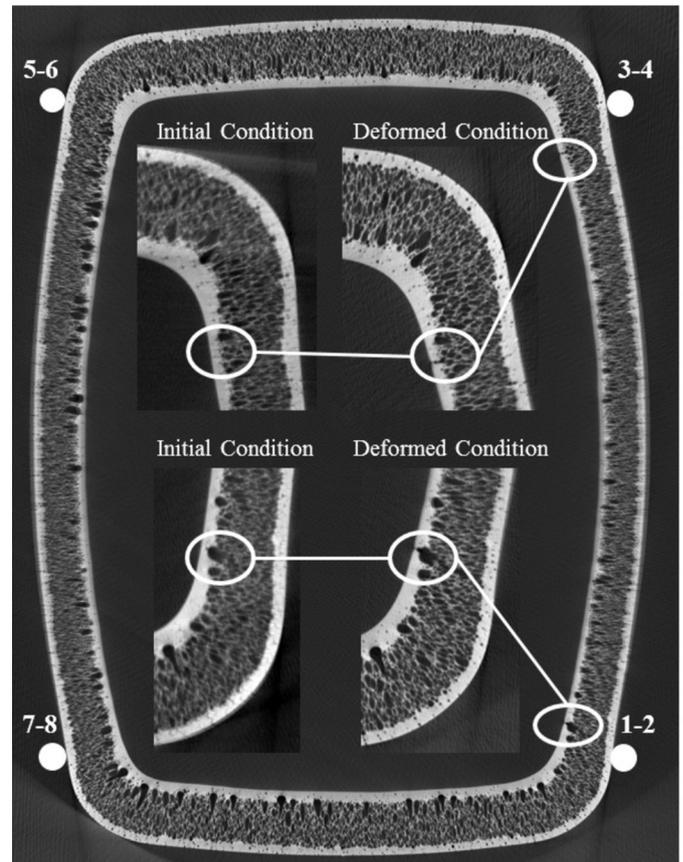
Fig. 15. Test 1. Section A of Figure 14 – location of rupture zone.

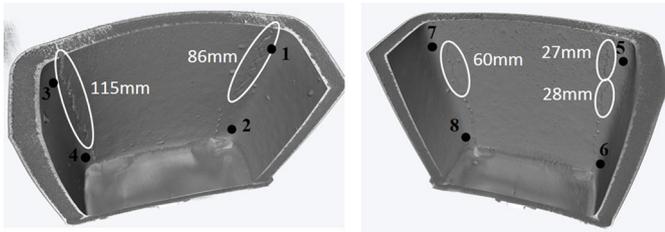
After the fourth cycle a scan of tomography has been performed. In Figure 18, it can be seen that the inner skin actually shows multiple cracks on the height of the bottle, which are located on the face that has expanded the most and close to the corners with different lengths (27 mm + 28 mm between sensors 5 and 6, 86 mm between sensors 1 and 2, 115 mm between sensors 3 and 4). Following the analysis of the tomography (Fig. 19), in the positioning section of the four sensors placed (section B in Fig. 19) at the top of the bottle, there are four luminous zones in the corners of the bottle, but on the side of the large face (those which inflate during the loading under pressure).

Fig. 18. Tomographs of the bottle after test 2.

However, in Figure 18, where the bottle is cut approximately 25 mm above the sensor positioning plane, it appears that only the cracks located in corners 1-2 and 3-4 and to a lesser extent in corner 5-6 have propagated since highlighted areas are present. However, they are less widespread than the areas located in section B. Finally, at the level of the positioning plane of the other sensors (2, 4, 6, 8), section A on Figure 19, no sign indicates the presence of water at the level of the foam. Section B (Fig. 19) of the bottler is the near area where there is the most swelling due to internal pressure. Thus, the crack opens and thus water can penetrate into the foam part.

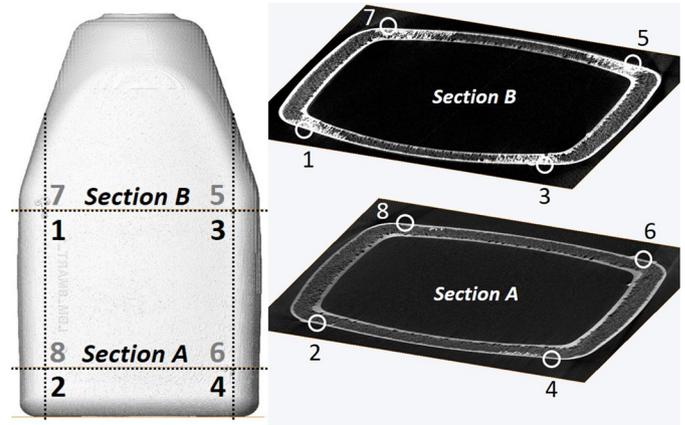
Fig. 19. Tomography of bottle section after test 2.

This corresponds to water infiltration at the foam level, which confirms that the internal skin is locally damaged.

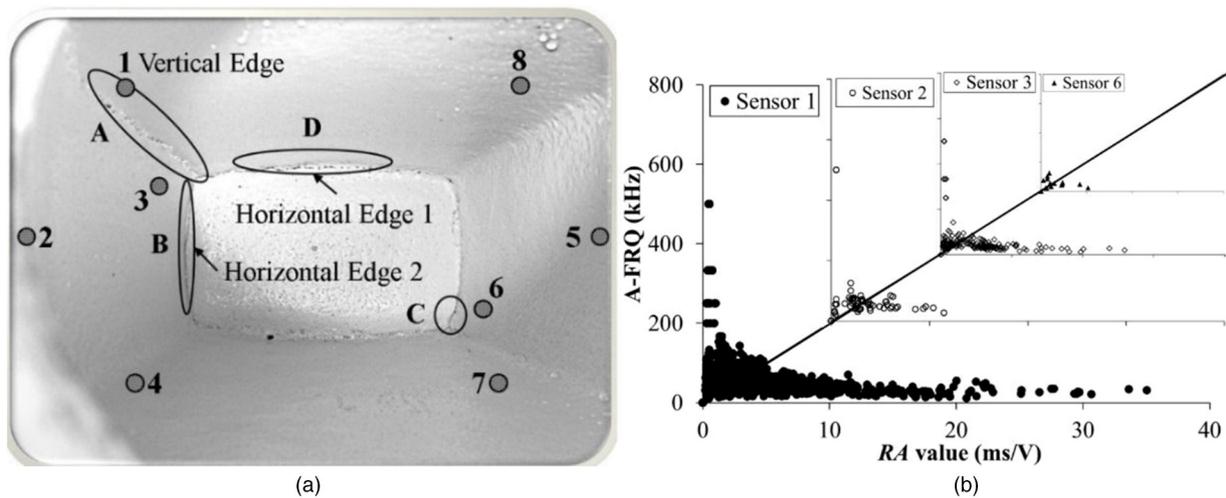
visual observation of the inside of the bottle leads us to notice that two cracks on the bottom of the bottle (at the level of the edges) and one on a vertical edge appeared. Contrary to the previous bottle, the rupture zones here are really located at the edges, i.e. in the angle (Fig. 24).

- Sensor 1 mainly detected the crack along the vertical edge noted **A** with amplitude up to 55 dB and secondary damage to the large horizontal edge.
- Sensor 2, which captured the least cost than sensors 1 and 3, appears to have perceived acoustic activity from the small horizontal 2 and/or vertical edge **A** and **B**. It is difficult to make a decision here, as this sensor is almost at an iso-distance from both edges.
- Sensor 3, which is also located at almost the same distance between the damaged edges.

Fig. 24. (a) Photo of the inside of the bottle after testing and disassembly areas of breakage of the inner skin of the bottle. (b) Relationship between average frequency (A-FRQ) and RA value.
