# A novel ball joint wear sensor for low-cost structural health monitoring of off-highway vehicles

**Key words:** Ball joint / wear sensor / preventive diagnosis / active safety / vehicles / wireless node / ultra-low power consumption

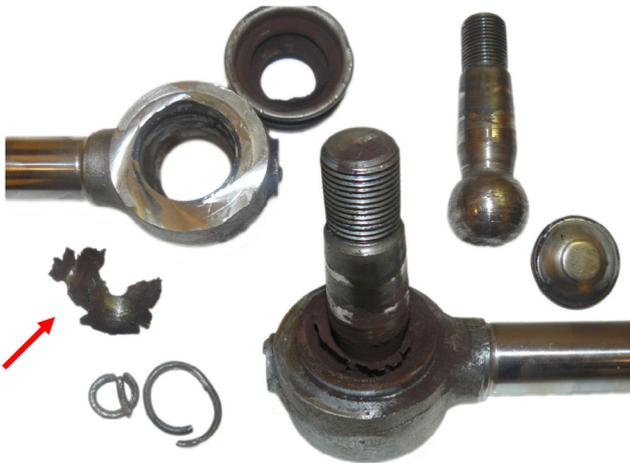
**Fig. 1.** Ball joint at the end of an endurance test performed without lubricating grease. The arrow highlights the completely failed conical upper bearing.

Wear originated by the relative movement between the ball and the socket is the most critical issue for this component, which can lead to failure also in long life ball joints [1–3], as demonstrated by a number of publications in the literature [4–9]. In order to reduce the friction and prevent wear, actual ball joints contain lubricating grease between the ball and the socket interface. Possible failure of the polyurethane sleeve that seals the ball joint and contains the grease leads to double drawback: the leak of the lubricant and the chance of having dirt and debris contamination of the joint. As a consequence, ball joint degradation occurs due to wear of the ball socket system, up to the complete failure which could cause catastrophic consequences (Fig. 1).

by a conical helical spring. In case of a lack of lubricant or in case the system is not correctly sealed thus contaminants get inside the joint, under working loads the wear occurring on the surface of the bearing damages the insulating layer. Through the cable connected to the bearing by means of a rivet (part 9 in Fig. 4) applied in the center hole, it is possible to measure the electric resistance between the bearing and the ball (up to short circuit condition): the lower the electric resistance, the higher the wear in the system. In conclusion, this wear sensor monitors the degradation of the upper bearing (part 2) in the ball joint, which is the most critical element and leads to complete failure of the joint (see Fig. 1).

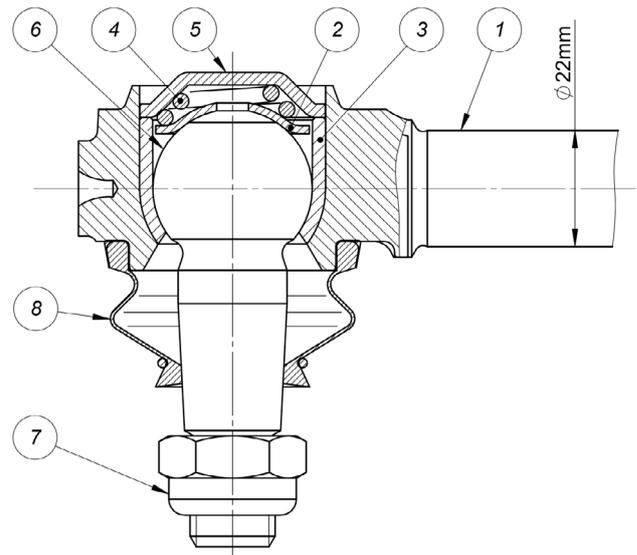
**Fig. 2.** Sketch of the ball joint: (1) piston rod, (2) upper bearing, (3) lower bearing, (4) helical spring, (5) upper cup, (6) ball-ended pin, (7) plastic-stop nut, (8) polyurethane sleeve.

Figure 2 shows the sketch of the ball joint that is installed in steering systems of off-highway vehicles having a power range from 50 Hp to 100 Hp. This ball joint connects the hydraulic cylinder piston rod (1) to the wheel spindle. The ball-ended pin (6) is pushed by the lower

bearing (3) and the spring (4) against the upper bearing (2). The friction between the ball-ended pin (6) and the upper bearing (2) is reduced by Molykote grease, which is confined by the polyurethane sleeve (8). The use in rough terrain can damage the polyurethane sleeve of the ball joint: the lubricant is washed away and the joint starts to wear. The aim of this work was to design and develop a wear sensor for the ball joint, in order to allow real-time diagnosis and preventive maintenance of the system.

The wear level of the joint is measured by means of a very simple circuitry. The basic principle is based on the classic voltage divider where the output voltage is the voltage drop across the joint,  $V_{\text{JS}}$  that varies over time during the normal joint operation from several mega ohms (new joint) to few ohms (worn out joint). This voltage is a fraction of the input voltage of the divider (i.e. the supply voltage of the sensor node,  $V_{\text{Supply\_JS}}$ ) and is proportional to the impedance measured on to the ball of the joint (i.e. between the upper bearing, part (2) in Figure 2, and the upper cup, part (5) in Fig. 2) accordingly with Equation (1):

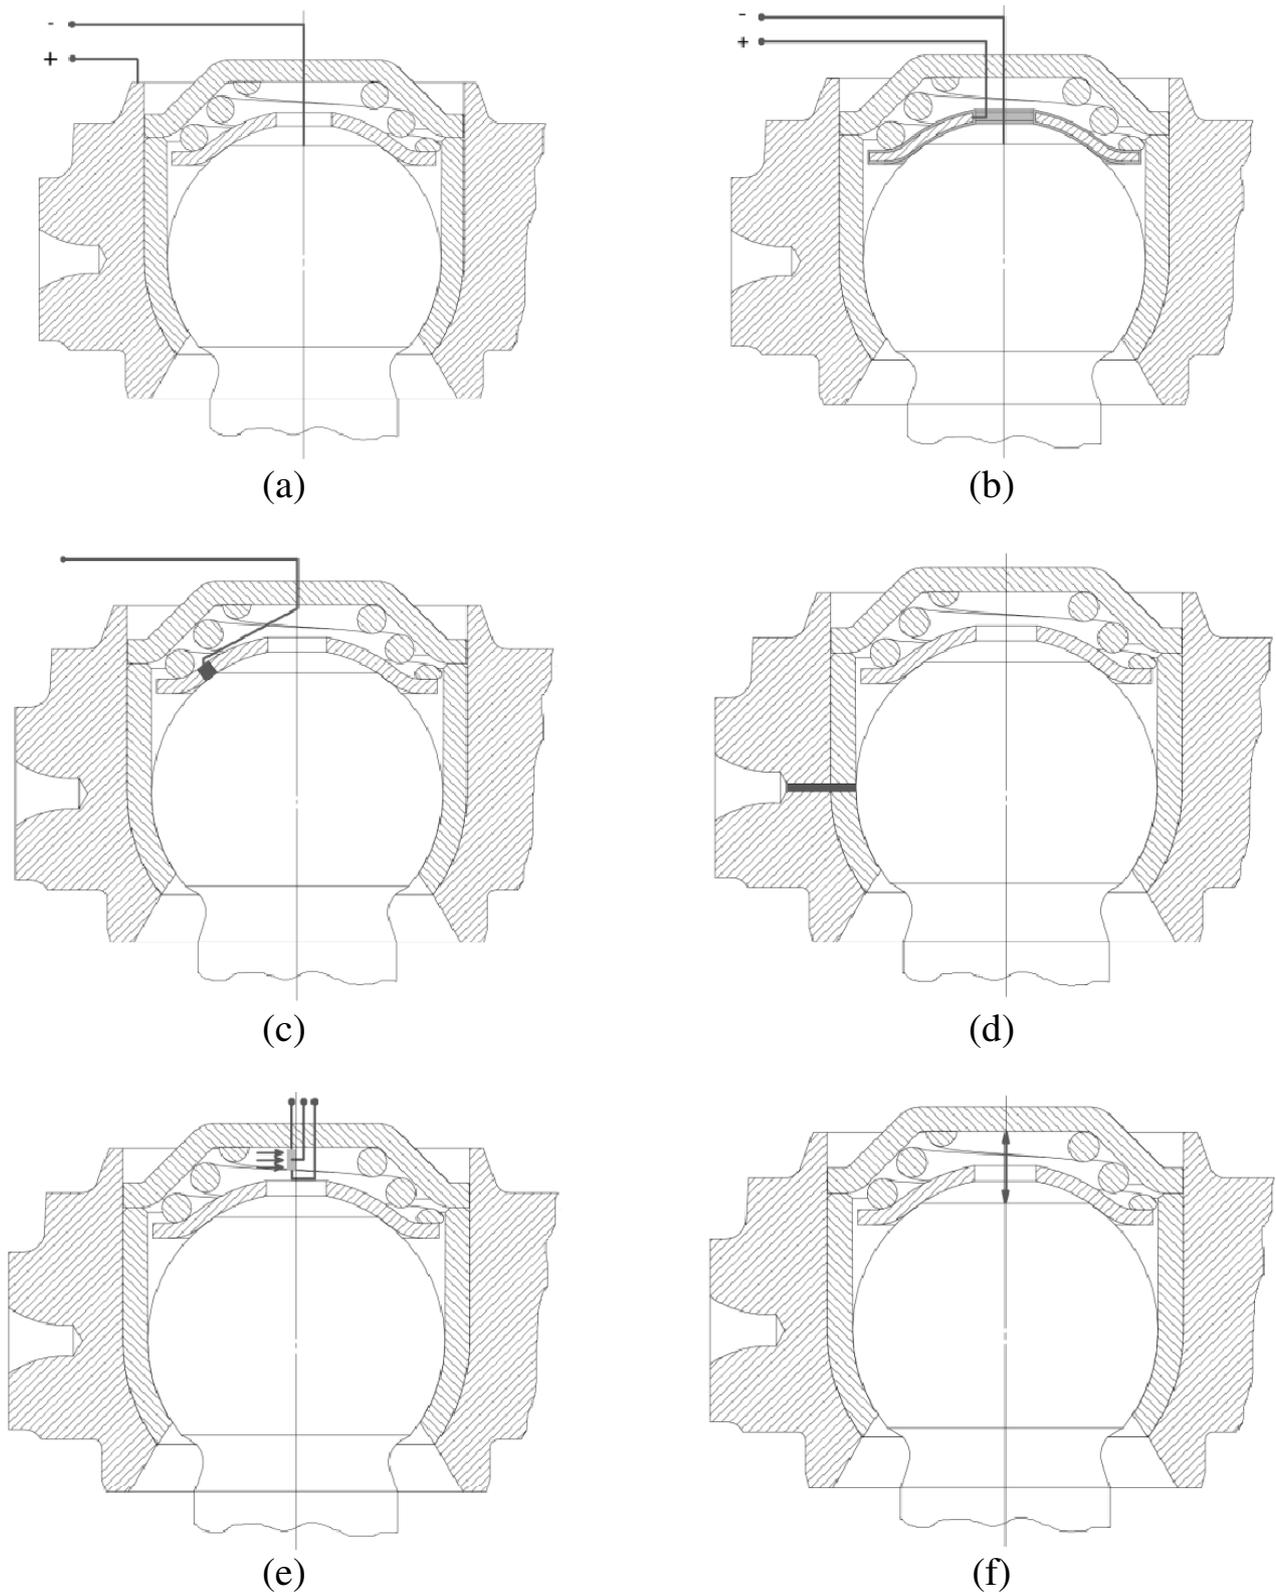
**Fig. 3.** Sensor concepts generation: (a) closed circuit between lower bearing and ball-ended pin; (b) open circuit between upper bearing and ball; (c) wearable sensing circuit embedded in the upper bearing, normally closed circuit; (d) wearable sensing circuit embedded in the outer case, normally closed circuit; (e) magnetic permeability sensor to measure the lack of lubricant inside the room of the ball joint; (f) displacement transducer to measure the relative displacement between the ball and the upper cup.

Figure 3 shows the concepts proposed for the ball joint wear sensor inspired by the preliminary investigation of the technical literature [10–14, 23–37]. Concepts shown in Figures 3a–3d rely on monitoring the resistance of an electric connection, which is either very low (i.e. short-circuit, Figs. 3a, 2c, and 2d) or very high (i.e. open Fig. 3b) during normal operation, and it switches to very high and very low value when wear occurs. The circuit is built between the ball pin and the outer case (Fig. 3a), or between the lower bearing and the ball pin (Fig. 3b). By contrast, in Figures 3c and 2d an insert containing different electrical paths is placed in the thickness of the lower bearing or

through a hole in the outer case and upper bearing respectively. All these solutions rely on the idea that the wear of the ball joint changes the electrical conductivity of the medium placed in between two conductive elements of the circuit.

The solution illustrated in Figure 3e correlates the wear to the lack of lubricant inside the room of the ball joint, which is detected by measuring the magnetic permeability of the lubricant itself. Another solution is proposed in Figure 3f where the relative displacement occurring during wear between the joint cap and the ball pin is measured using a displacement transducer.

Figure 4 shows the detailed technical sketch of the concept proposed according to Figure 3b. This solution shows three main advantages compared to those proposed in Figure 3 and compared to the patents traceable in the literature [10–14]. First, the wear sensor relies on an open circuit in normal conditions, hence the power consumption is zero unless the failure occurs. Second, this solution is simple, easy to be integrated into the current architecture of ball joints and thus inexpensive. Third, this solution is more reliable compared to other concepts in Figure 3.

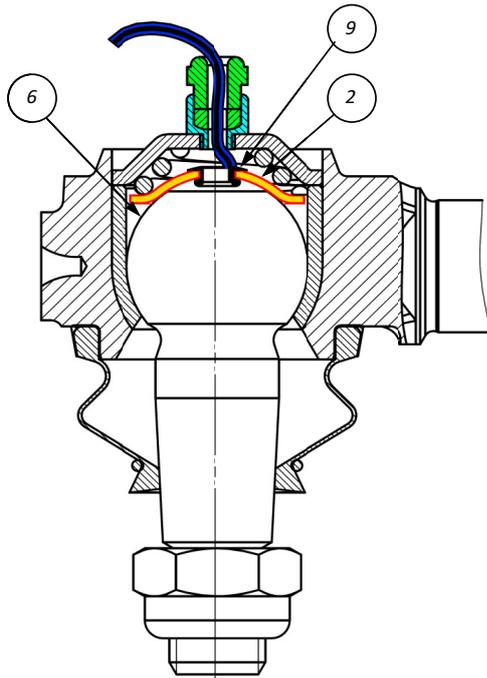
**Fig. 4.** Section view of the wear sensor included in the ball joint.

The operating principle of the wear sensor is based on the variation of electrical resistance between the pin-ball (part 6 in Fig. 4) and the upper bearing (part 2 in Fig. 4). In normal conditions (no damage occurred), the upper bearing (part 2 in Fig. 4) is coated by an insulating shield to achieve a very high resistance, i.e. an open circuit between the bearing and the ball (part 6 in Fig. 4). This conical bearing is pressed against the ball-ended pin

Figure 6 shows the prototype of the ball joint including the wear sensor manufactured according to the technical drawing in Figure 4. The upper cup (part 5) in Fig. 2) and its locking system were slightly modified in order to allow rapid disassembly of the joint, thus simplifying periodic inspections during tests. All other parts of the system belong to a standard ball joint provided by Ognibene S.p.A.. With reference to the sketch shown in Figure 2, the ball-ended pin (6) is made in quenched steel. Two different materials were considered for the upper bearing (2): carburized and hardened mild steel or aluminum. The lower bearing (3) was made with the same carburized and hardened material as the upper bearing. The wires come out from the center of the joint cup through a plastic coupling. The sleeve (8) is made of polyurethane having grade 385E, with hardness equal to 85 ShA. All the system is locked by a plastic-stop nut (7). The electrical connection to the upper bearing was obtained by welding a wire to a rivet which is then fixed to the upper bearing (2).

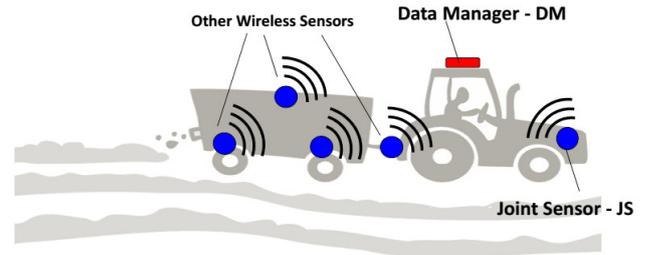
**Fig. 5.** System architecture.

Figure 5 shows the electronic system architecture. In this paper we considered the case study of a joint used in off-highway vehicles: the DM device designed to be positioned on the cabin of the tractor works as the access point for the data transmitted from the JS and other wireless sensors on the vehicle

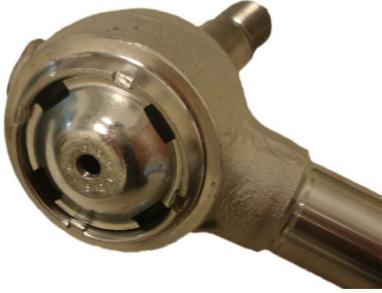
**Fig. 6.** Prototype of the ball joint including the wear sensor.

The experimental assessment was performed on the prototype of the ball joint implementing the wear sensor (Fig. 6). The experimental campaign examined each of the three types of coatings of the upper bearing described above (Rilsan, Loctite Nordbak 7227, and anodic oxidation on an aluminum bearing). In order to speed up the wearing of the ball joint, thus shortening the tests, only a minimum amount of lubricant was introduced inside the prototype and the polyurethane sleeve was removed. This condition emulates the damage of the polyurethane sleeve on the field, where only a small amount of Molykote stays inside the joint. The normal lubrication condition was not examined, since, according to previous tests performed by

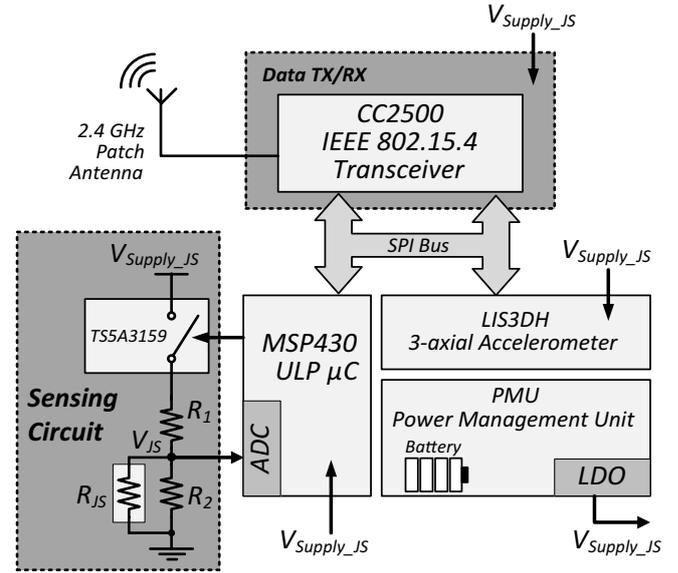
**Fig. 7.** Simplified Block Diagram of the Joint Sensor Device – JS.

Figure 7 shows the simplified block diagram of the implemented Joint Sensor (JS) incorporating the wear sensing circuit (bottom left block) described in the former sections. The core of the device is an ultra-low power microcontroller ( $\mu\text{C}$ ) of the MSP430 family from Texas Instruments which achieves good performances with ultra-low power consumption (i.e.  $\approx 250 \mu\text{A}$  when running at 1 MHz, and  $\approx 500 \text{nA}$  in sleep mode) and embeds several communication interfaces (i.e. UART, SPI, I<sup>2</sup>C). The JS is provided with an inertial sensor (LIS3DH, 3-axial MEMS accelerometer from STMicroelectronics) for detecting the motion and measuring joint accelerations. The adopted accelerometer consumes only 10  $\mu\text{A}$  with 100 Hz sampling frequency, while draining only 500 nA in power-down mode. When in active mode, the sensor can measure acceleration with maximum frequency of 5 kHz and full scale up to  $\pm 16 \text{g}$ . The  $\mu\text{C}$  periodically polls the accelerometer to detect the presence of vibrations, which allows detecting if the joint is on duty.

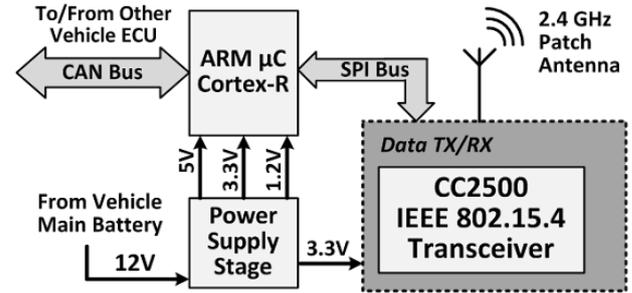
Fig. 8. Simplified Block Diagram of the Data Manager Device – DM.

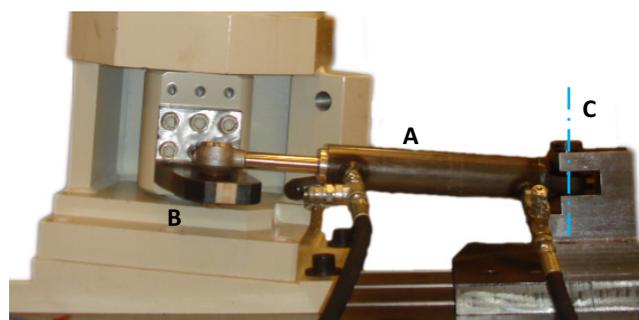
Fig. 9. Testing equipment for the ball joint wear sensor.

The sensor was monitored through a data acquisition module (USB 6251 from National Instruments [40]) which measured the electric resistance and registered the number of cycles up to failure. The failure of the system was assumed to occur when the impedance between the upper bearing and the external frame of the ball joint dropped down to 50% of the initial value. Three replicates were performed for each type of coating, and the ball joint was tested up to failure.

The test procedure aims to reproduce the fatigue loading which affects the ball joint in real working conditions. According to the proprietary standard from Ognibene, the test bench has to mimic the same geometry and kinematics of the front axle of a tractor, in order to describe the typical motion law occurring in service conditions. The cycles are performed at a frequency equal to 0.2 Hz, by controlling the force. The load on the joint equals 70% of the maximum shear force for the ball joint along the stroke, while reaches 100% of the maximum shear force at the end of stroke. The tests were performed through the ad-hoc hydraulic testing machine available in the Ognibene research lab (Fig. 9). This test bench reproduces on the ball joint the motion law and forces prescribed by the company standard, which was inspired by the Japanese automotive standard (JASO-C615-89) [39]. Thanks to a peculiar kinematic link, the ball-ended pin axis sweeps a conical surface during each cycle, with an opening angle of 20°. This motion law is obtained by combining the alternate translation of the piston rod (A in Fig. 9) which rotates on the hinge C, to the cyclic rotation of the bracket connected to the hydraulic brake simulating the wheel spindle (B, in Fig. 9), inclined with respect to the hinge C. The test machine is equipped with a 25 kN load cell installed along the axis of the piston and is supplied by an 11 kW hydraulic power unit. The whole system is controlled through a hardware in the loop program developed in Labview [40].

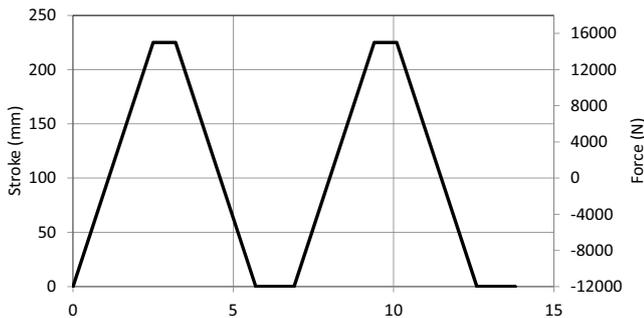
Fig. 10. Motion law on the steering actuator during the test.

Figure 10 shows in detail the combination of the motion law and the loading cycle applied to the system in the experimental tests, which originate a maximum shear force on the ball-ended pin of the joint up to about 16 kN.

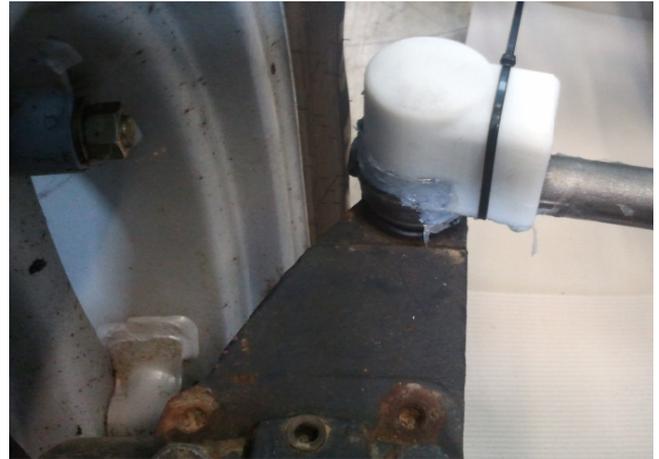
Fig. 11. Prototype of the ball joint including the wear sensor and the electronic board encapsulated in a plastic case, installed on the test tractor.

A Landini Power Mondial 120 tractor [41] was used for the validation of the prototype in real working scenarios. Figure 11 shows a prototype of the ball joint including the JS enclosed in the rapid prototyped white ABS box. On each connection of the front axle of the tractor with the wheel spindles, we installed a prototype, including an aluminum bearing with anodic oxidation. Both wear sensors were managed by the DM device installed in the cabin.

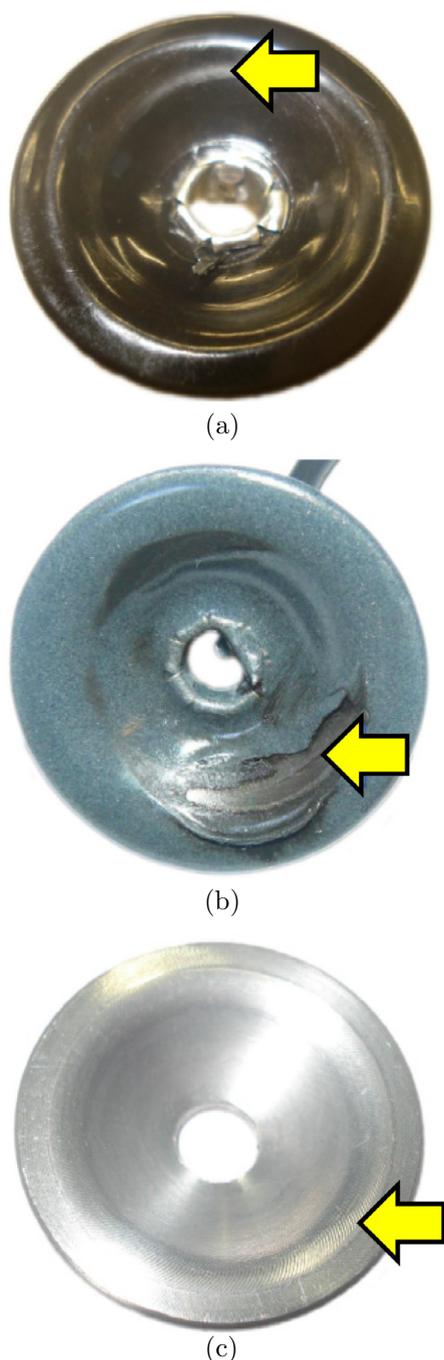
**Fig. 12.** Failed upper bearing coated with Rilsan (a), Loctite Nordbak 7227 (b), and anodized aluminum (c).

Table 4 collects the average number of cycles up to failure for each type of coating. At the end of each test, the ball joint was disassembled and the coated bearings

With regard to the different types of coatings, all of them provide a good wear resistance before failure, but with regard to manufacturing, the Rilsan coating and the anodic oxidation are easier to be produced.
