Acoustic emission description from a damage and failure scenario of rotomoulded polyolefin sandwich structure subjected to internal pressure for storage applications

Eric Lainé^{1,*}, Jean-Claude Grandidier¹, Maxime Cruz¹, Anne-Laure Gorge¹, Claire Bouvy², and Geert Vaes²

¹ Institut Pprime, CNRS, ISAE-ENSMA, Université de Poitiers, 86962 Futuroscope, France

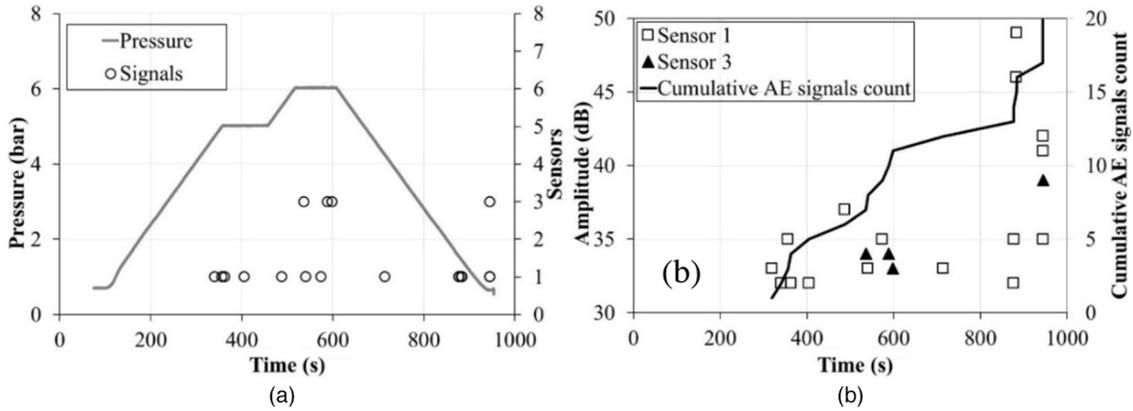
Fig. 12. Test 1. (a) Pressure and sensors vs time. (b) Amplitude and cumulative AE signals count vs time.

At the first loading, acoustic signals (only AE hits) are received on sensors 1, 2, 5 and 7. The maximum pressure is 2 bar. The exploitation of tomography does not provide any information to establish a link between the first AE hits and local degradation of the inner or outer skin. A second charging is carried out up to 5 bar and stopped when two acoustic signals appear on the monitor. Similar to the previous tomography it does not provide any information. The third test is interrupted very quickly because an AE signal appears at 1 bar. But once again, nothing is observed visually or by imagery. These first hits are either due to very local damage or to noise from the machine. However, the characteristics of the signals are very close to those observed at the point of loss of linearity in the traction curve. The signals have a very low RA value and a high A-FRQ. Of course, it is not possible to completely exclude machine noises but the comparison with the first events under traction is convincing enough to associate these events to the initiation of the first damage in the same manner as the tensile test. In this case, the tomography is not precise enough to locate and observe the consequences of these mechanisms which should be cavitation mechanism.

For the fourth load, it is envisaged to go up to 5 bar, and to continue by steps of 1 bar according to the detection rate of acoustic signals (Fig. 12a). An acoustic activity (AA) already appears between 4 and 5 bar on sensor 1 and then on sensor 3 between 5 and 6 bar (Fig. 12a). The test continues with a constant bearing at 6 bar. In addition to sensor 1, acoustic signals are received by sensor 3. The test is interrupted after these 10–11 hits to scan the bottle again because as already stated, the aim is to correlate the AA and damage, and thus avoid an excessive breakage of a skin. At the end of the discharge, 2 new hits can be seen on sensor 1 with a slightly higher amplitude. Figure 12b shows that during pressure relief, the acoustic activity accelerates slightly (9 hits between 400 and 1000s) with a higher intensity because the signal exceed 40 dB. Note that the other sensors (2,4,5,6,7,8) did not perceive any acoustic signals during the test. This first test suggests that the first hits are either the signature of the initiation of the first damage or perhaps parasitic machine and assembly events that are recorded with the required filtering (Fig. 13a). The first hits at 40 dB are well in tune with wall breaking mechanisms, which are the first mechanisms that appear during pressure build-up. The distribution of hits in Figure 13a are similar to those measured under tensile stress. The A-FRQ and RA characteristics match to

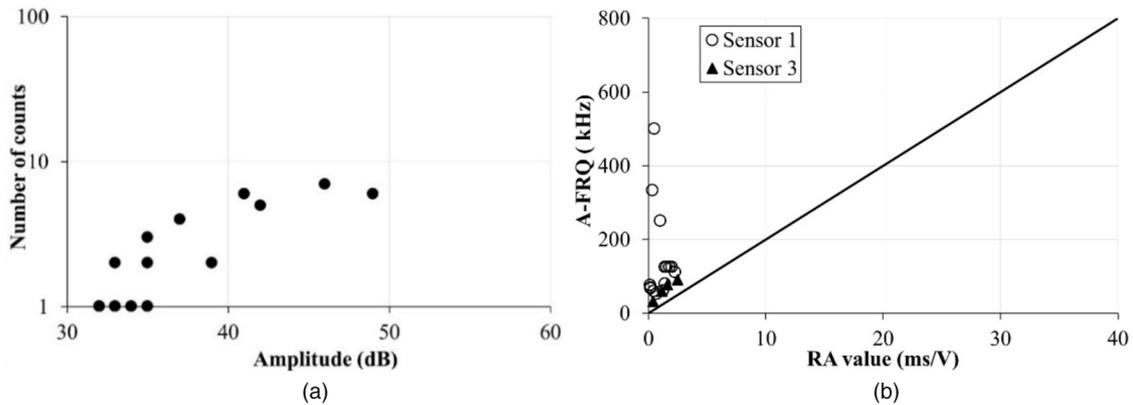
Fig. 13. Test 1. (a) Number of counts vs amplitude (dB). (b) Relationship between average frequency and RA value.

distribution of initiation of damage under the traction tests. It seems reasonable to associate these hits to initiation of damage and the first small crack in inner skin.

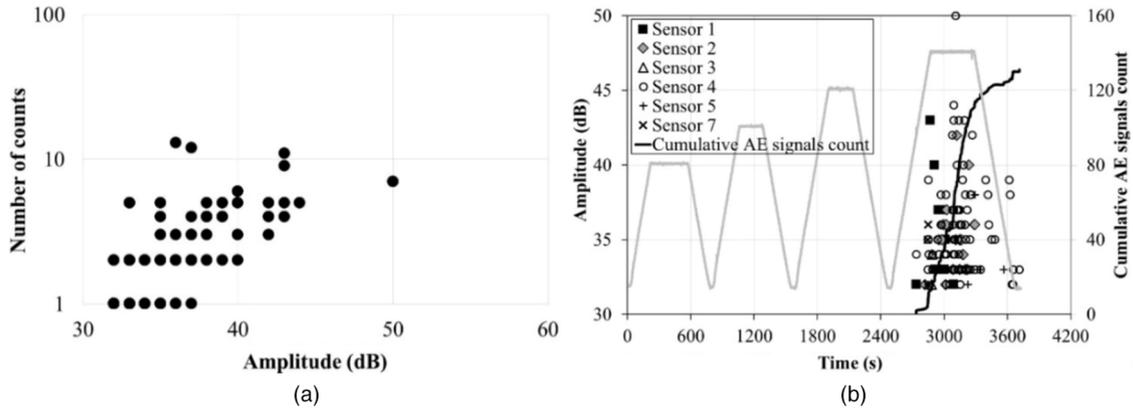
pairs 1-2 and 3-4 (Fig. 17). Lower activity was observed on corners 5-6 and 7-8 and sensors 6 and 8 did not detect acoustic signals. Either they were incorrectly positioned or the intensity was too low to be detectable in these areas due to high damping of polymer. However, Figure 18 shows that the cracks at angles 5-6 and 7-8 are the smallest, respectively 55 and 60mm. Moreover, the distance between their ends and sensors 6 and 8 is still high, which does not allow acoustic signals to be detected. However, sensors 2 and 4 picked up signals and their quantities are proportional to the length of the measured cracks and especially to the position of their end. Indeed, the crack between sensors 3 and 4 is the longest, and sensor 4 is the one that detected the most hits. Finally, note that the amplitudes remain low since all the hits are below 45 dB with 93% of the population between 32 and 40 dB.

Fig. 16. Test 2. (a) Number of counts vs amplitude (dB). (b) Pressure load-unload in 1bar steps vs time – Amplitude of signals on different sensors vs time – cumulative AE signals count vs time.

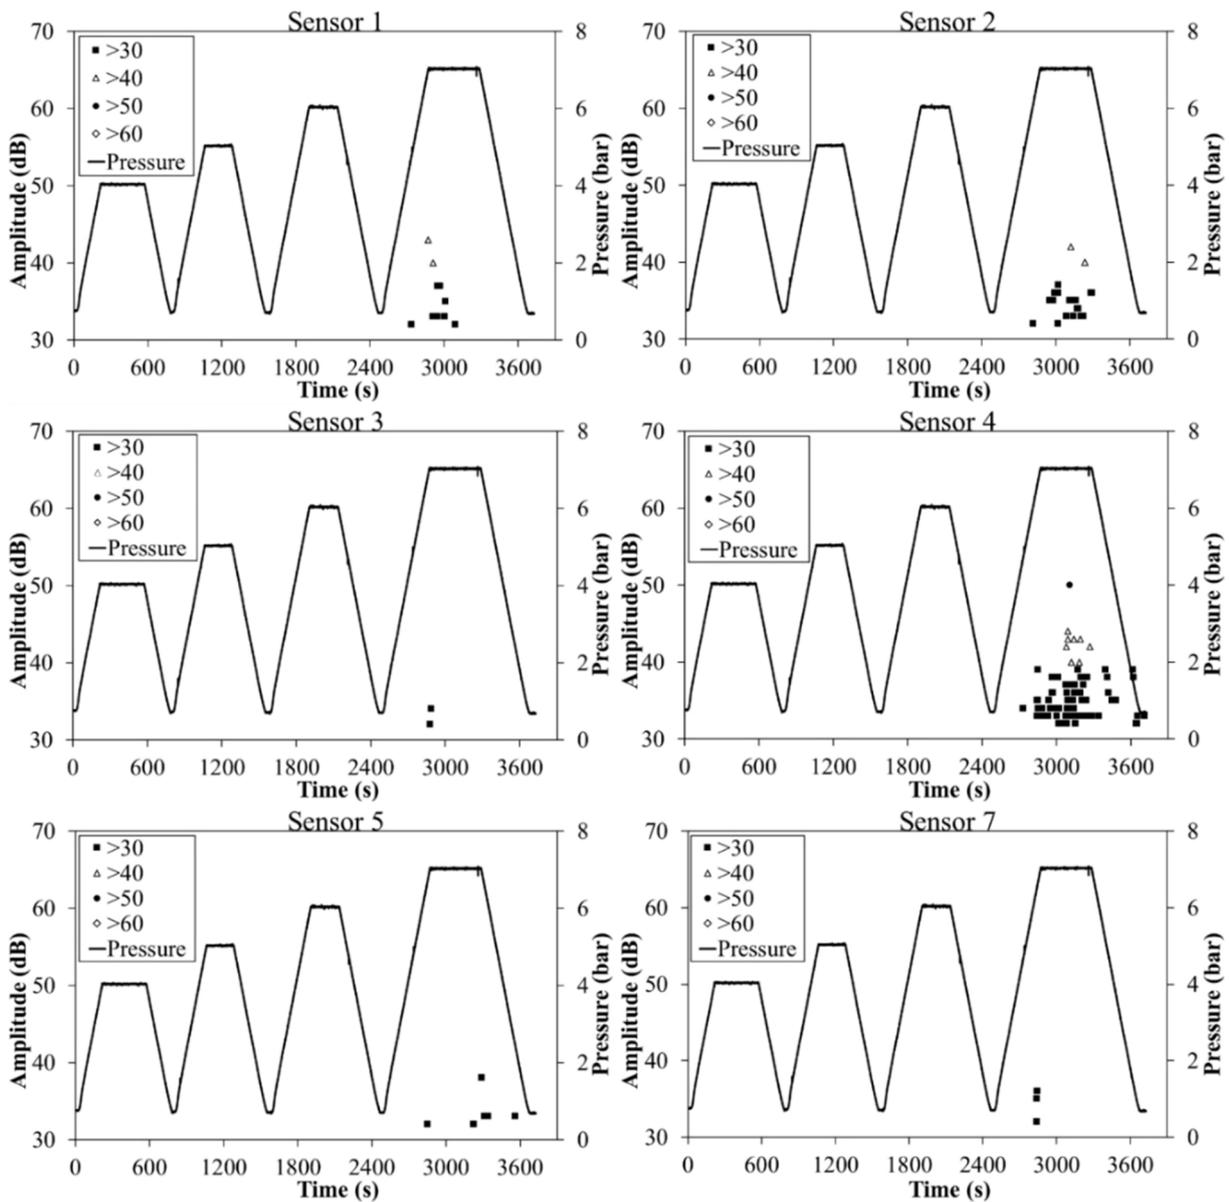
Fig. 17. Amplitude of signals on different sensors.

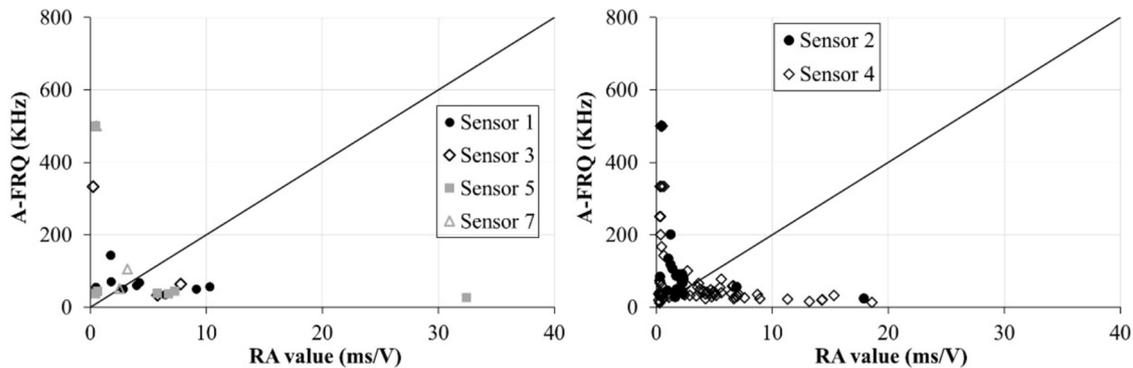
Fig. 20. Test 2 relationship between average frequency and RA value for each sensors.

Compared to the previous test, the analysis of the acoustic emission signals shows that low A-FRQ and strong RA value hits appear, which correspond to the characteristics of the events observed under large strains in a tensile test. The tomography showed a tearing of the inner skin, unobservable in the previous test, consequently it is reasonable to associate these new hits to the spread of damage. This propagation involves localization of deformations and tearing. In Figure 20, as many hits with low and high RA values are generated which is a link to the process area with cavitation followed by propagation (tearing).

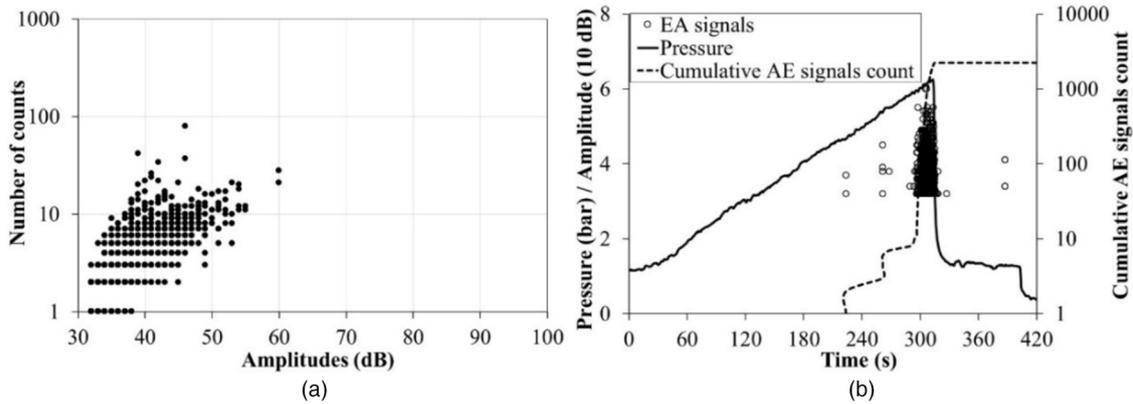
Thus, from 6 bar pressure (Fig. 22b), the AE signals intensify rapidly (Fig. 22b) and mainly on sensors 1, 2 and 3 (Fig. 23), but no activity of sensors 4, 5, 7 and 8 and a very low activity of 6 is observed. After disassembly of the entire assembly (bottle and specific assembly) of the machine, then after removing the specific assembly and completely emptying the bottle, it is visible that the inner skin of the bottle has several important cracks (Fig. 24). Thus, the

Fig. 22. Test 3. (a) Number of counts vs amplitude (dB). (b) Monotonic test under internal pressure – internal pressure, amplitude vs time and cumulative AE signals count vs time.

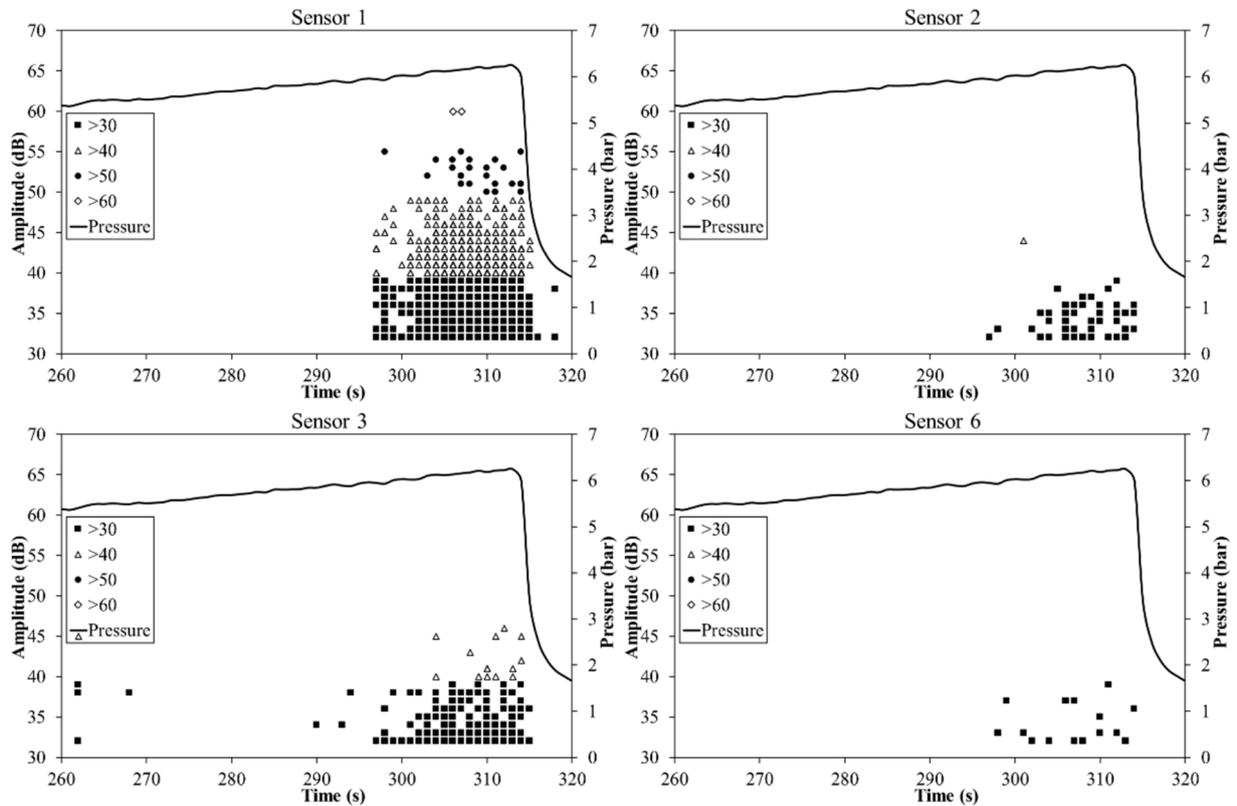
of the positioning of the sensors in relation to the location of the damage. On the other vertical edges no damage is observed, which may explain why the other sensors (4,5,7,8) did not detect any signals. In view of the damage areas, it is reasonable to assume that, although the signals are weak, sensors 3 and 6 (Fig. 24b) have detected damage to the horizontal edges **B** and **C** of the bottom of the bottle (Fig. 23). Since it is likely that the signals perceived by sensor 1 correspond to the damage to the vertical edge but also to the two horizontal edges of the bottom of the bottle. Although the position of the sensors has been changed, it is difficult to localize the rupture zones perfectly. Despite it is a different polyolefin, one finds a very similar scenario, the observations with Ray-X are identical (Fig. 24a) and the AE signals present the same characteristics with the distributions A-FRQ function of RA value similar (Fig. 24b).

Fig. 23. Amplitude of signals on different sensors.

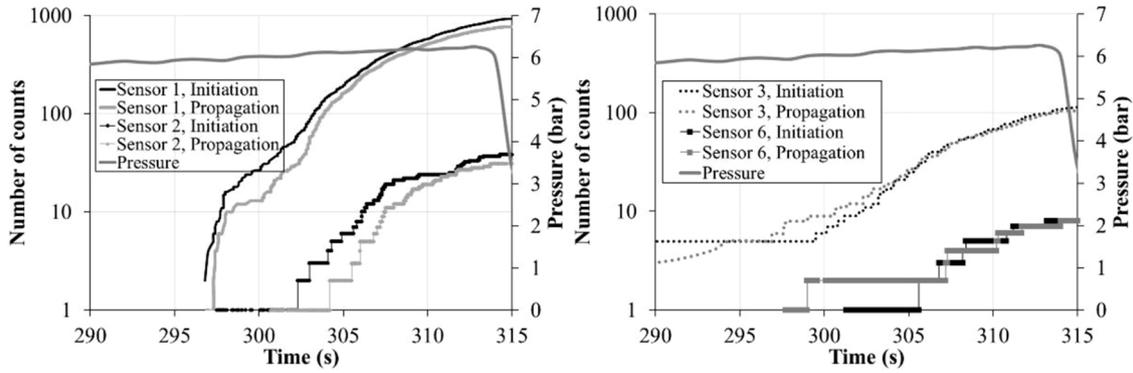
Fig. 25. Relation between load and crack generation on the time domain – Test 3.

From the point of view of the kinetics, Figure 25 gives the temporal evolutions of the numbers of counts, relative to the two mechanisms during the test, a perfect synchronization of the signals is observed with the curves of the phenomenon of initiation in advance of phase of that of spread, this point correspond to evolution in the structure of process zone.

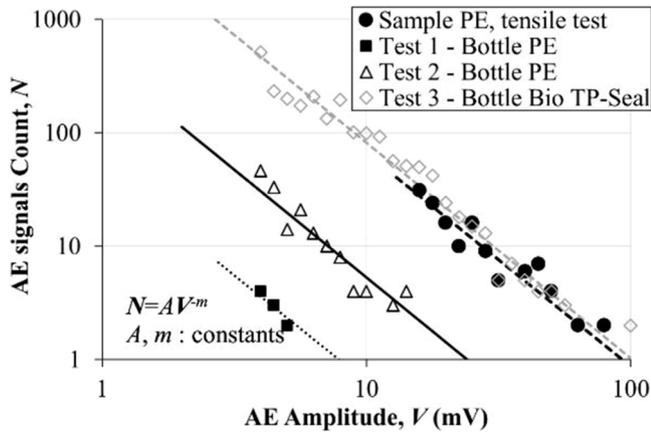
Figure 26 shows the AE event count (N) and amplitude (A_{mv}) obtained from the bottle during the static internal pressure test. The data at $N \geq 1$ was plotted, since a few AE signals were generated due to the swelling process. From equation (8), the value of the coefficient m can be identified directly from the points in Figure 26.

Fig. 26. Relationship between the number of AE signals and the AE amplitude obtained from tensile test and bottle tests.

For the tensile test, the value of m is 1.90 for amplitudes greater than 42 dB (12.6 V). For tests 1, 2 and 3 on bottles, where there was sufficient acoustic activity to exploit these quantities, the value of m is 1.90, 1.90 and 1.88, respectively. Fracture behaviour is correlated with this slope, consequently the value obtained for this semi-crystalline material is representative of crack growth on energy that is between steel and rubber. For fatigue crack growth of a steel material, it is reported that $m \approx 2$ [41]. Yamabe et al. [40] determined that $m = 1.8$ from the rubber material for the static crack growth test.
