Non-destructive testing of metallic materials using passive and active infrared thermography

Abstract – In this work, we approach the possibilities of infrared thermography for non-destructive testing of metallic materials. We show that the passive alternative of the method makes it possible to improve detection of surface defects existing in deep-drawn parts and visible to the naked eye. We then show that active infrared thermography, in particular coupled with induction excitation, can replace in certain cases the magnetic particle inspection, allowing the detection of very fine defects in forged parts. Finally, the study of a stepped block confirms the possibilities of active infrared thermography to detect defects not open to the surface and underlying defects.

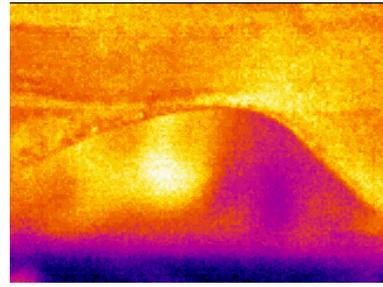
Fig. 1. Thermogram obtained during the study of a sound car suspension part.

The first study developed in passive infrared thermography concerns the detection of cracks in car suspension parts. These parts are 3 mm thick approximately, and cracks can appear during the parts forming process. We analysed sound and defective parts. The results obtained are presented in Figure 1 for the sound part and in Figure 2 for the defective part. They clearly show that a crack gives a higher radiation signal at the exact location of the defect, thereby allowing detection.

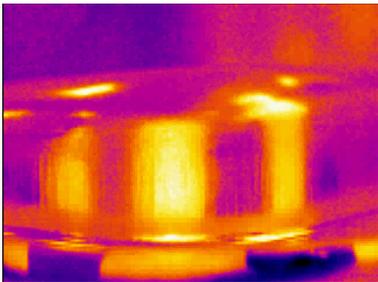
Fig. 3. Thermogram obtained during the examination of a sound crankcase.

sound crankcase, the second one has an incipient crack and the last one has a through crack. As the previous result showed the feasibility of the method, we wanted in this new study to approach the experimental conditions encountered at the outlet of a deep-drawing press. For that purpose, we covered the crankcases with a film of grease to simulate the drawing lubricant. The results obtained are presented in Figures 3 to 5. Figure 3 corresponds to the thermogram obtained during the examination of the sound crankcase. Figure 4 corresponds to the thermogram obtained during the examination of the incipient crack; it shows a peculiar radiation signature at the location of the crack. This shows the possibilities of passive infrared thermography to detect this type of defects in conditions close to those found in a factory. Figure 5 corresponds to the thermogram obtained during the examination of the cracked crankcase. Here again, a higher radiation signal is visible at the location of the defect, thereby allowing its detection. Finally, the comparison between Figures 4 and 5, shows that the radiation signature of the defect is higher for a deeper defect.

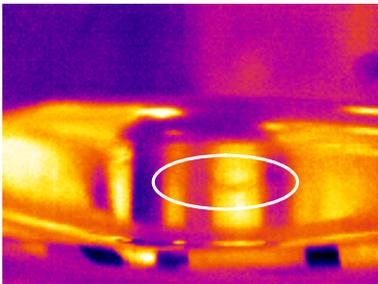
Fig. 4. Thermogram obtained during the examination of a crankcase with an incipient crack.

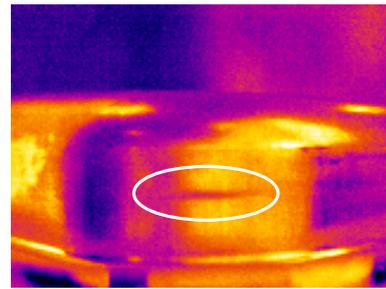
Fig. 5. Thermogram obtained during the examination of a crankcase with a through crack.

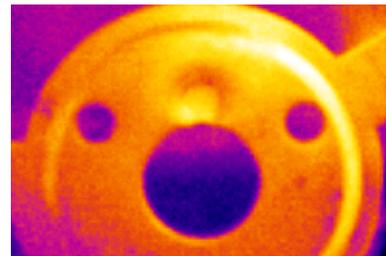
Fig. 6. Thermogram obtained during the examination of a car mounting plate exhibiting an appearance defect caused by a migrating chip (chip side).

The third study developed in passive infrared thermography concerns the detection of migrating waste in car mounting plates made of steel. This is an appearance defect of industrial parts, caused by chips which migrated in the tooling. As in the previous cases, Figures 6 and 7 show the possibility of detection of this defect, as it changes the surface radiation properties of the part.

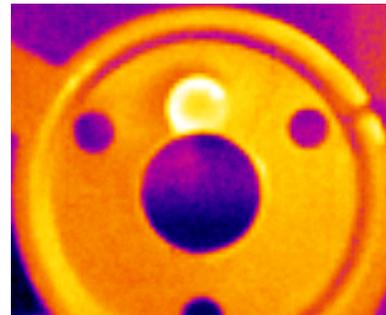
Fig. 7. Thermogram obtained during the examination of a car mounting plate exhibiting an appearance defect caused by a migrating chip (face opposite to the chip).

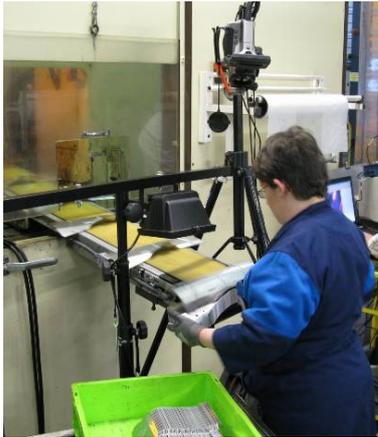
Fig. 8. Experimental device selected for the study.

The parts were analysed as they travelled in the production line; therefore, they were warm and covered in lubricant. The infrared camera was installed at press outlet. It continuously shot the parts to be inspected (Fig. 8).

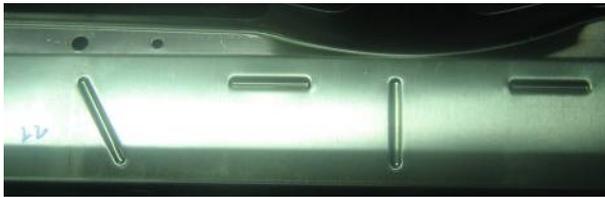
Fig. 9. Sound part.

During this measurement campaign, approximately one hundred parts were inspected, among which approximately ten defective parts. As in the previous case, these defective parts were characterised by an appearance defect (Figs. 9 and 10).

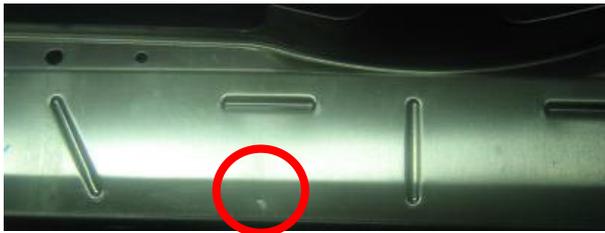
Fig. 10. Part exhibiting an appearance defect caused by a migrating chip.

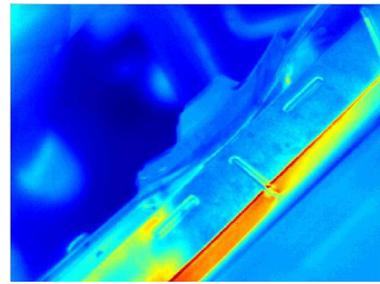
Fig. 11. Thermogram obtained during the study of a sound part.

The results obtained during this on-site study are presented in Figures 11 and 12. Figure 11 corresponds to the typical result obtained during the analysis of a sound part. Figure 12 corresponds to an example of result obtained during the analysis of a defective part. These figures clearly show that, even in an industrial situation, the presence of a defect generates a radiation signature which can be detected using passive infrared thermography. This result is very interesting since it can pave the way for real time, on-site detection of appearance defects.

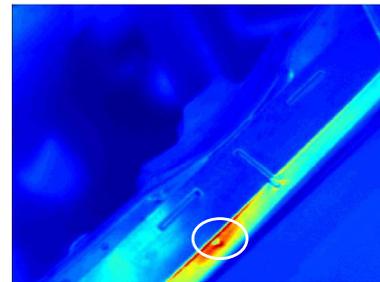
Fig. 12. Thermogram obtained during the study of a part exhibiting an appearance defect caused by chip migration.

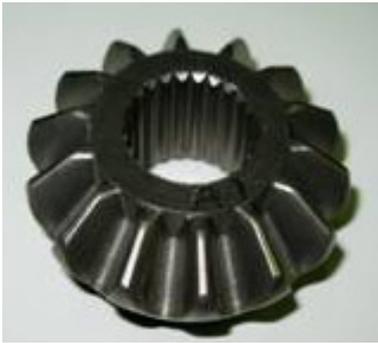
Fig. 13. Analysed transmission gear.

The first sample we studied using active infrared thermography was a cracked transmission gear (Fig. 13).

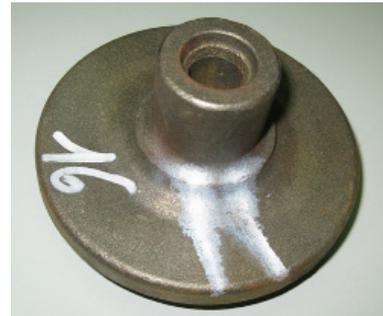
Fig. 16. Analysed forged hub.

The objective of the next study was to assess the possibilities of the infrared method to detect very small forging laps located in a hub (Fig. 16).

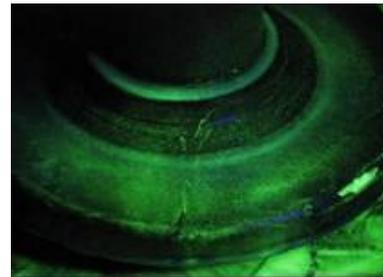
Fig. 17. Magnetic particle inspection of the hub (flat face).

naked eye. The first crack extends from the flat face of the part to the fillet radius (Fig. 17). The second crack is located in the fillet radius (Fig. 18).

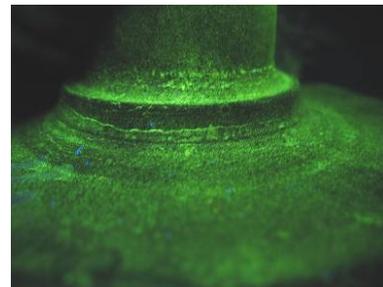
Fig. 18. Magnetic particle inspection of the hub (fillet radius).

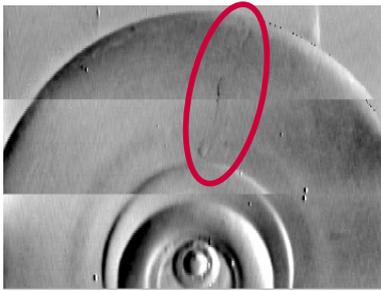
Fig. 19. Thermogram obtained during the examination of the hub (laser excitation).

Then we analysed this sample using active infrared thermography and with three different excitation modes: laser, flash lamp and induction. The results obtained are presented in Figures 19 to 23. Figure 19 corresponds to laser excitation, it shows an indication in the fillet radius of the hub. However, this excitation source, which allows good defect detection, is not compatible with the inspection rates on this type of industrial parts. Figures 20 and 21 correspond to the inspection of the hub after optical excitation using a 3.5 kJ flash lamp; they show higher photothermal signals at the location of the defects, thereby allowing detection. In this case, the inspection is much faster but it is susceptible to the variations of emissivity of the part to be inspected. Finally, the last tested excitation was induction. The principle is based on generating eddy currents in the part to be inspected by sending a high alternating current in a coil located in the vicinity of the part. These currents will heat the part through Joule effect. Figures 22 and 23 show the most contrasted

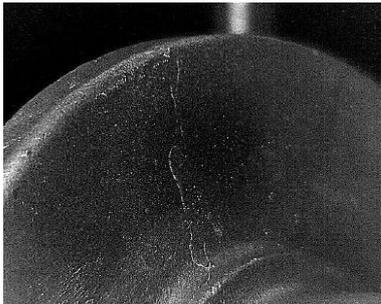
Fig. 20. Thermogram obtained during the examination of the flat face of the forged hub (flash lamp excitation).

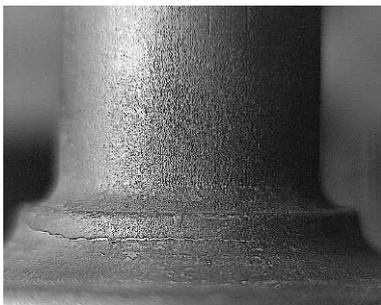
Fig. 21. Thermogram obtained during the examination of the fillet radius of the forged hub (flash lamp excitation).

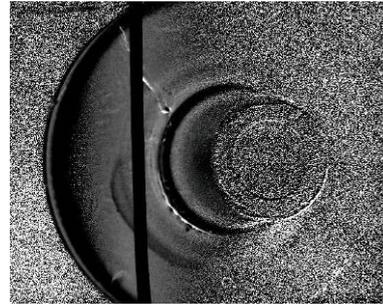
Fig. 22. Thermogram obtained during the examination of the flat face of the forged hub (induction excitation).

signatures of the methods implemented in this study. Furthermore, the implementation of induction excitation is compatible with the industrial constraints encountered in a forging plant. This study demonstrates that induction thermography is very interesting to detect micro-cracks.

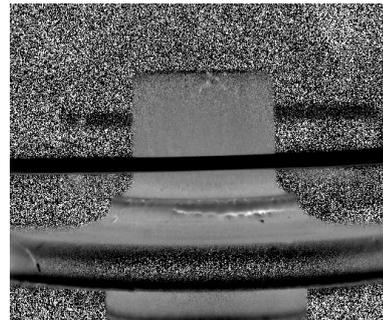
Fig. 23. Thermogram obtained during the examination of the fillet radius of the forged hub (induction excitation).

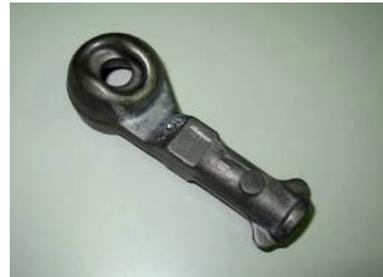
Fig. 24. Analysed forged ball joint.

Further to this very positive study, we continued our investigations on a forged ball joint (Fig. 24).

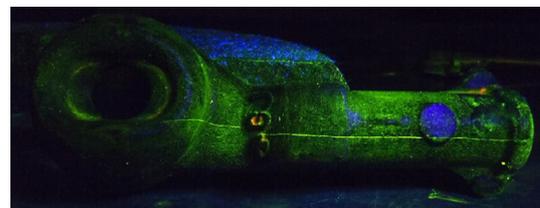
Fig. 25. Magnetic particle inspection of the forged ball joint.

The conventional magnetic particle inspection revealed the presence of a crack over the entire length of the ball joint (Fig. 25).

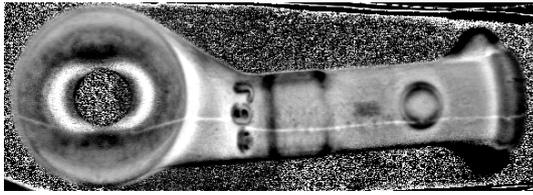
Fig. 26. Thermogram obtained during the active infrared thermography analysis of the forged ball joint.

The result obtained with induction excitation thermography is presented on Figure 26. It shows a white line which corresponds to the photothermal signature of the crack, further to a 140-ms acquisition which included 70 ms of induction excitation and 70 ms of cooling.

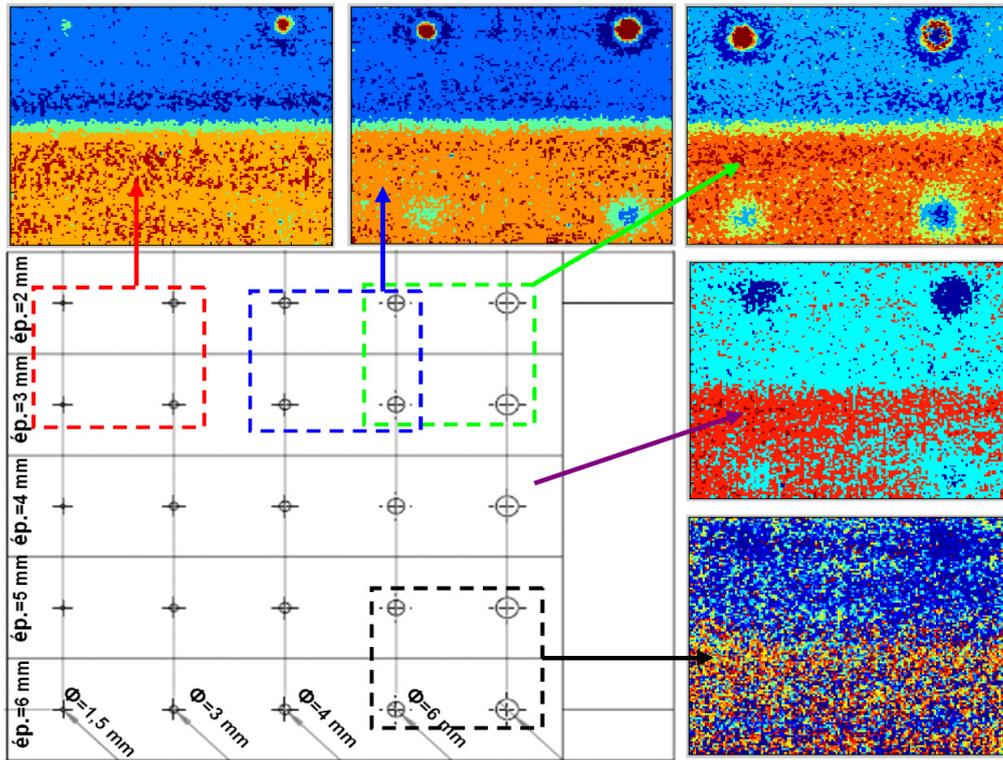
Fig. 30. Analysis of a stepped block using infrared thermography with flash lamp excitation.

The result obtained with flash lamp excitation infrared thermography is presented in Figure 30. First, this

result shows that this method actually allows defects not open to the surface to be detected, then it gives a few indications as to the limits of the method. On the one hand, it shows that this method allows detection of defects with diameters of 6 mm and 8 mm down to a depth of 5 mm, and on the other hand it shows that the method allows detection of a defect with a diameter of 3 mm down to a depth of 2 mm. And, finally, it shows that, at a depth of 1 mm, all defects were detected.

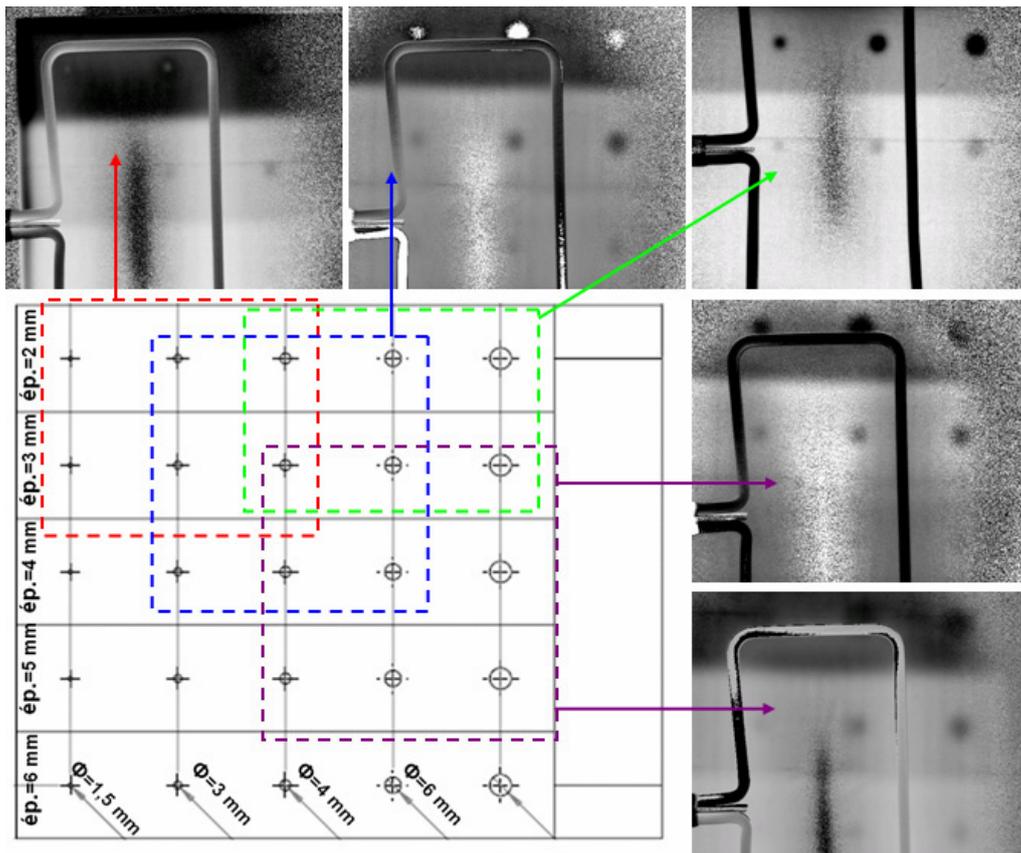
Fig. 31. Analysis of a stepped block using infrared thermography with induction excitation.

Then we examined this stepped block using infrared thermography associated with induction excitation. The result obtained is presented in Figure 31. It first shows that this method also allows defects not open to the surface to be detected. Then it shows less diffuse defect signatures than with the flash lamp excitation method. Finally, it shows that this method allows detection of flat-bottomed holes of 4 mm, 6 mm and 8 mm down to a depth of 4 mm, detection of holes with a diameter of 3 mm down to a depth of 3 mm, and detection of holes with a diameter of 1.5 mm down to a depth of 2 mm. This active infrared thermography variant then seems to be the variant which allows a wider detection of defects. It seems to show the possibility to detect a defect at a depth equal to its diameter. Therefore, this method could be used to inspect thin plates and it might become useful to detect, for instance, losses of thickness due to corrosion.
