## Proof of a composite repair concept for aeronautical structures: a simplified method

**Abstract.** This paper provides an illustration of all stages of primary aeronautical composite structure repair by using industrial tools and scientific methodologies, as well as numerical tools to simplify the cross-over analysis of the mechanical behaviour of the repaired area. Economically and scientifically speaking, one of the main challenges of composite repair (for monolithic long fiber composite parts) consists of promoting a bonded composite patch option without additional riveted doublers. To address this challenge, size reduction of the patch could be mandatory. A patent (jointly owned by ICA, Bayab Industries and CES), entitled “Method for repairing a wall consisting of a plurality of layers”, is devoted to reducing repair patch dimensions of monolithic composite parts provided the bonding zone has a stepped-lap geometry. This patent is based on a simple idea that no overlapping length is required between composite plies for load transfer except in the fiber directions of the plies (unidirectional or biaxial long fiber reinforcements with epoxy matrix). To prove this concept, we

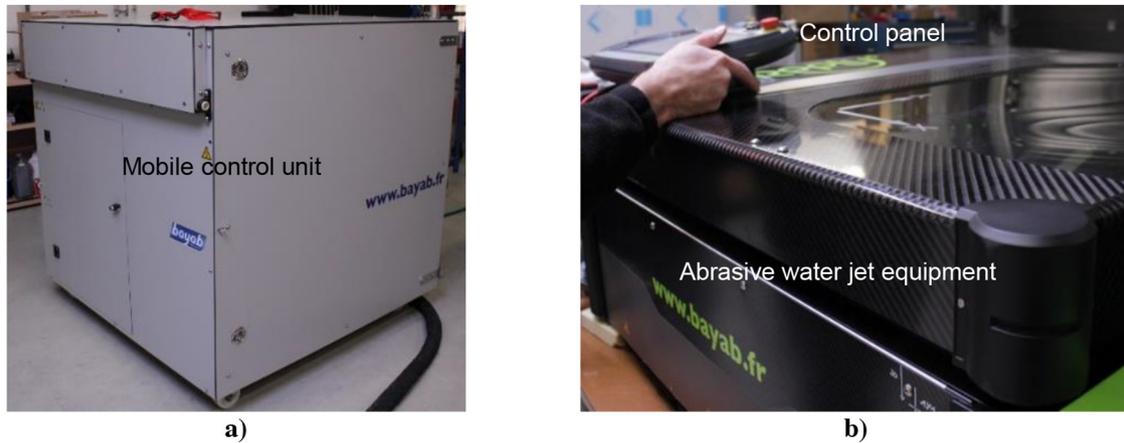
**Fig. 3.** Bayab Industries abrasive water jet machine REPLY.5 with (a) control unit and (b) abrasive water jet equipment (50 kg) and control panel.

The first stage of this study corresponds to the fabrication and machining process of a monolithic carbon-epoxy composite plate. For this study a 16 ply composite plate of  $[((+45^\circ/-45^\circ)_s)_s]$  was made from a UD Hexply<sup>®</sup> M21/35%/268/T700GC prepreg, cured in autoclave at 180 °C. Afterwards the plate is cured and then machined. Three step ratios (step length over ply thickness) were studied, 20, 30 and 50, which roughly correspond to overlap lengths of 6 mm, 8 mm and 13 mm respectively. The machining is done using the abrasive water jet (AWJ) removal technique. The AWJ blind machining was performed by a mobile machine (REPLY.5, cf. Fig. 3).

The REPLY.5 AWJ machine consists of three principal elements, the control unit which contains the pump and the control system (cf. Fig. 3a), the abrasive water jet equipment (which is light –50 kg – compared to the competing project attempts) and the control panel to operate the machine (cf. Fig. 3b).

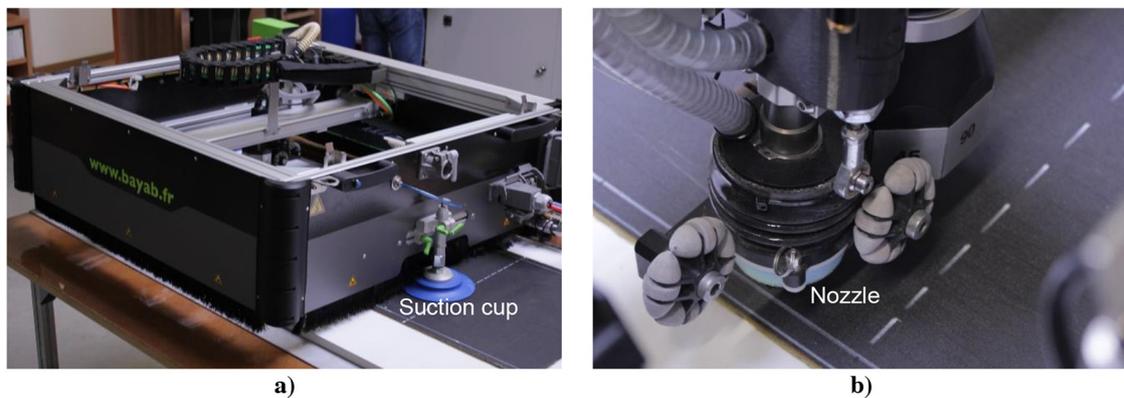
**Fig. 4.** Abrasive water jet machine Reply.5 with (a) levelled machine and (b) nozzle.

After fixing the composite plate onto the workbench, the AWJ machine is placed on top of it and is maintained in position with suction cups (cf. Fig. 4a). In an industrial situation, this suction system allows the positioning of the machine onto a composite fuselage. The machine is then levelled to roughly adjust the distance between the AWJ head (nozzle) and the composite part (cf. Fig. 4b).

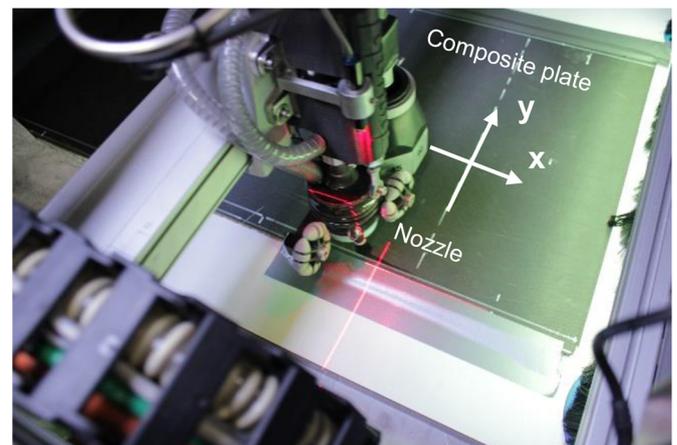
**Fig. 5.** Alignment process of the nozzle over the  $x$ - and  $y$ -main directions of the composite plate.

The machine is aligned by a laser level to the marked along the  $x$ - and  $y$ -main directions of the studied parent composite plate (cf. Fig. 5).

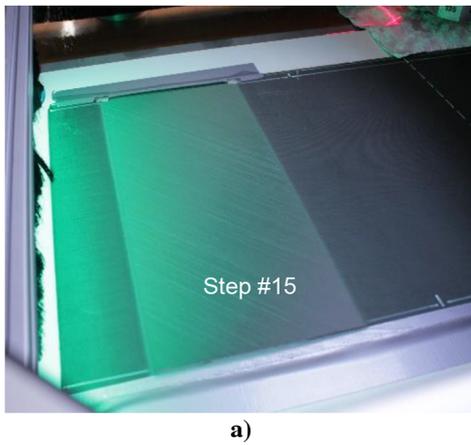
**Fig. 7.** Verification process of the machining surface with (a) overlap zone analysed by image analysis and (b) visualization and selection of the images on the control panel to estimate the location of the interface between to plies (i.e. presence of numerous dark spots due to no light diffraction).

lightning emitted by the low-angled light is diffracted differently depending on the angle with respect to the long fibre orientation. The control unit compares the recorded images pixel-by-pixel. For accurate information, a selection of images from the screen of the control panel (cf. Fig. 7b)

shows an estimation of the matrix ratio (percentage of dark spots thanks to no light diffraction,  $\approx 60\%$  according to ply thickness variabilities, [9]) in an interface between two plies. The matrix ratio is evaluated to ensure that just one ply was removed. This is an alternative to direct measurement of the cut depth.

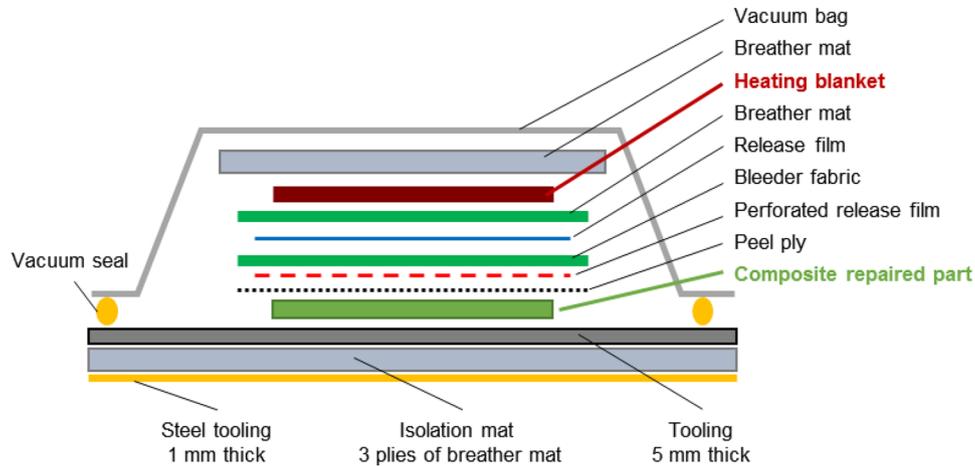
**Fig. 11.** Scheme of the vacuum bag products (not to scale) for the composite patch curing by heating blanket (according to SRM A350 chapter 51.77.11, see [6]).

Once all the repair plies are laid up, the vacuum bag is installed. The sequence of vacuum bag materials is done as per Airbus SRM indications for structural composite repair (cf. Fig. 11).

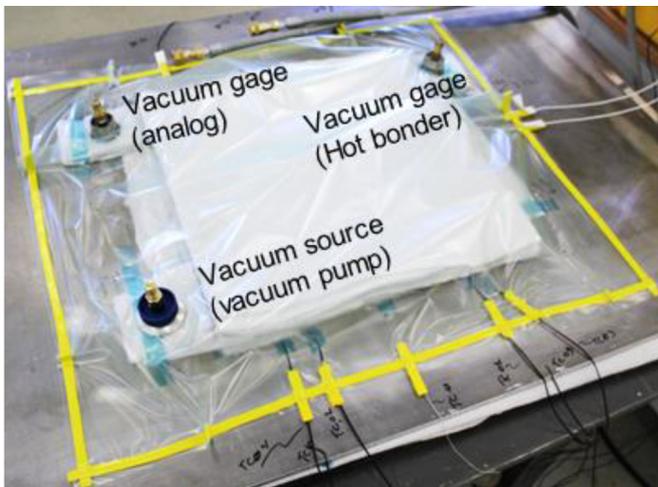
**Fig. 12.** Overview of the vacuum bag products and the connections to the different thermocouples.

Once the vacuum bag is placed and sealed, a vacuum test is performed. The vacuum is applied using the external vacuum pump (cf. Fig. 12).

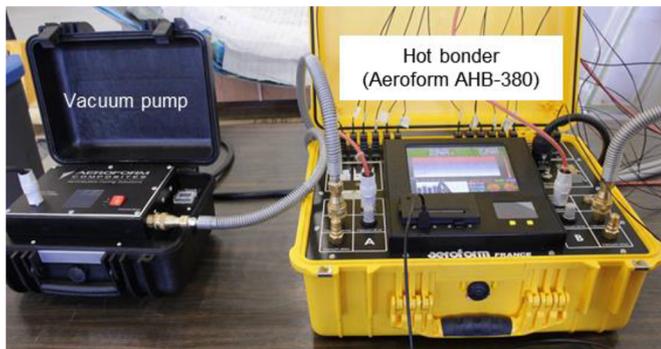
**Fig. 13.** Portable hot bonder Aeroform AHB-380 (right) and the portable vacuum pump (left).

The temperature cycle is programmed into the hot bonder (cf. Fig. 13). The M21 resin cures at  $180^{\circ}\text{C}$  for 2 h. An intermediate dwell at  $100^{\circ}\text{C}$  for 30 min is used in order to homogenise the temperature in the unconsolidated patch prepreg and to promote the movement of resin and

removal of entrapped air causing porosities in the material. The temperature ramps are set at  $3^{\circ}\text{C min}^{-1}$ . The vacuum is applied with an external portable vacuum pump (cf. Fig. 13).

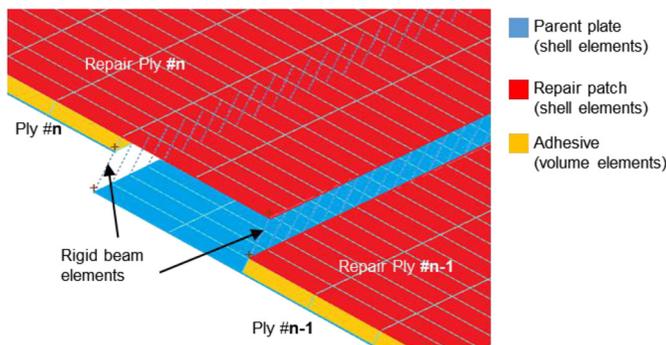
Fig. 15. Mesh detail between two consecutive steps (ply #n and #n-1).

A light finite element (FE) modelling strategy is used [5,7]. This strategy uses shell elements for the composite laminate and volume elements for the adhesive joint (cf. Fig. 15). The mesh of the composite parent zone is modelled with shell elements of  $0.44 \times 0.44$  mm dimensions. One volume element of 0.1 mm thick with the same width and length as the composite shell elements is employed to model the adhesive film with a thickness to length ratio of 1:4.

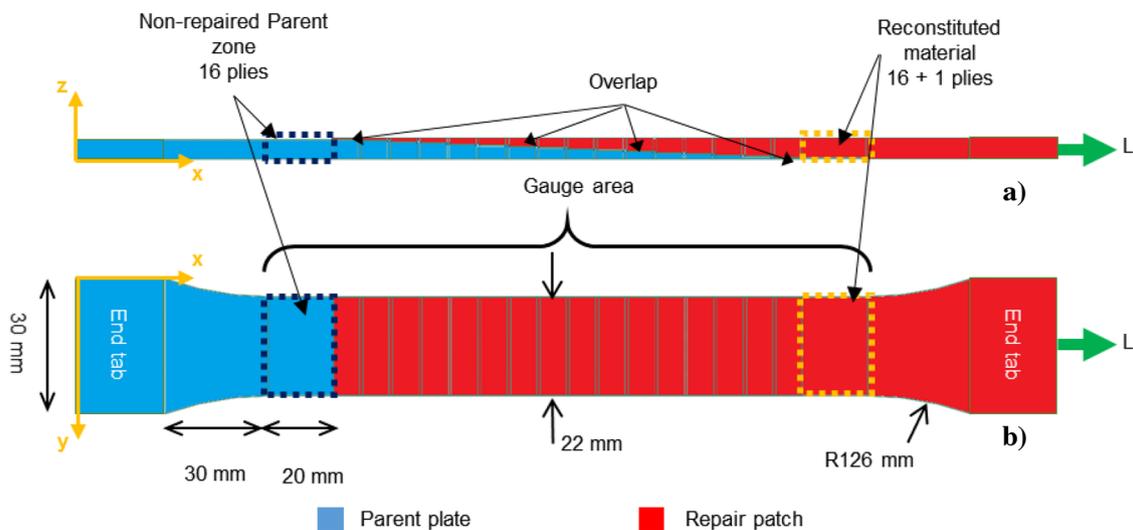
Fig. 16. 3D representation of the FE model (shell thicknesses rendered at their given values) with (a) side view (XZ plane) and (b) top view (XY plane).

The shape of the tensile repaired coupon is shown in Figure 16. The repaired coupon is 22 mm wide in the gauge zone, corresponding to the overlap zone. Its end tabs are 30 mm wide in order to avoid a possible material failure at the machine clamps. The zone of 20 mm length approximately located between the overlap and the tab is considered as representative of a non-repaired area. This zone corresponding to the non-repaired zone of the parent

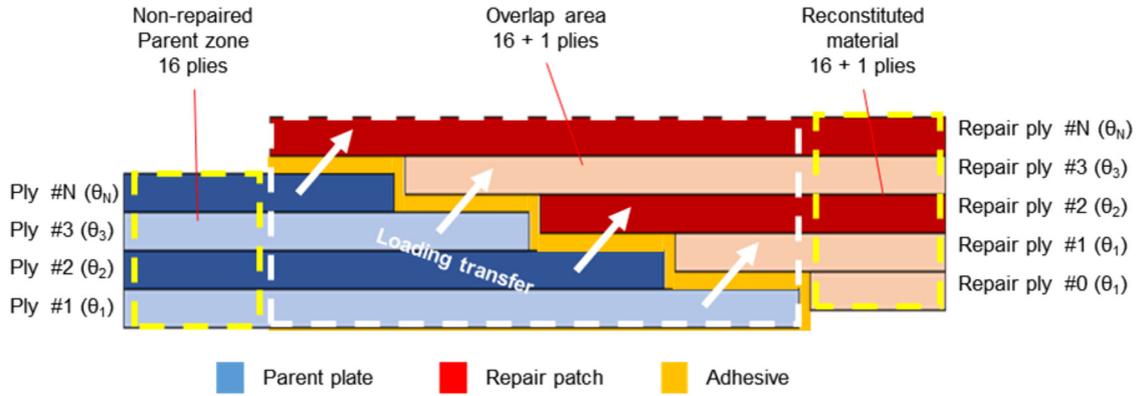
Fig. 17. Scheme of composite repair overlap considerations (not to scale).

zone has the original parent plate of 16 plies, while the reconstituted material in the patch area has one extra ply (repair ply #0) with the same orientation as the repair ply #1. This filler ply is only used to ensure continuity of the bottom surface of the repair, and to provide support for the stacked plies, otherwise there would be ply waviness in the rest of the stack. Thus, this zone has a stacking sequence with 17 plies in total in accordance with composite repair implementation (cf. Fig. 17). As in Figures 2 and 17 uses white arrows to show the loading flow transfer principle from the parent plies to the repair plies.

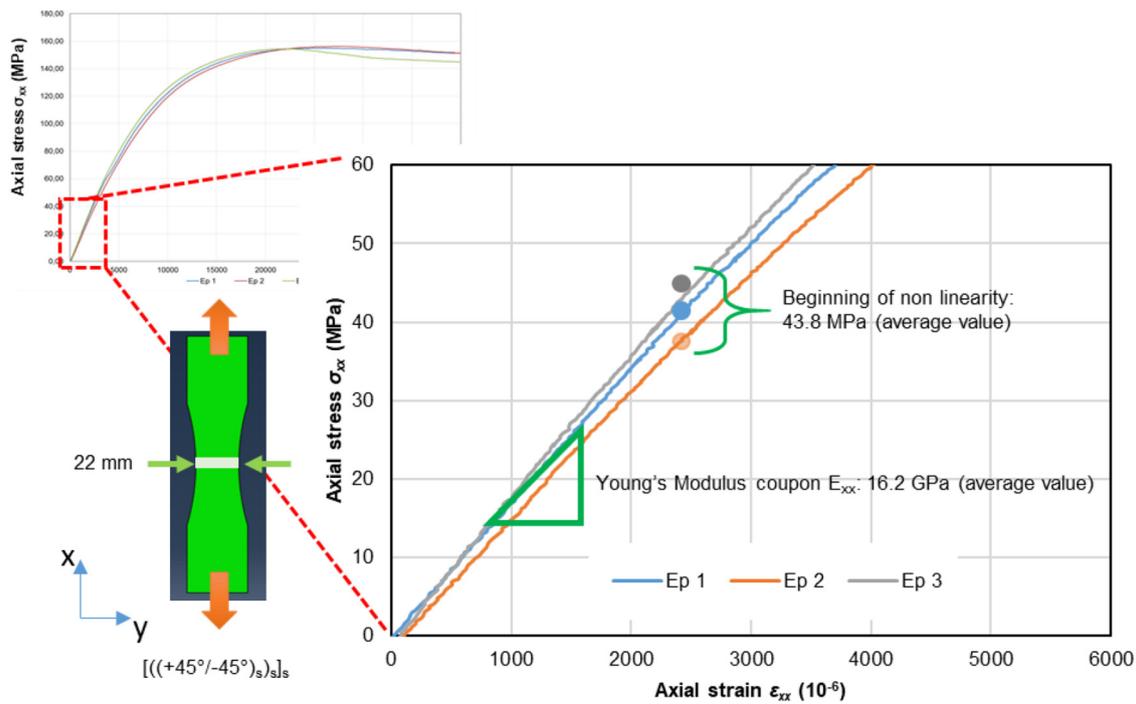
Fig. 18. Inverse identification of the material properties (at the beginning of the non-linear behaviour) using a tensile test on unrepaired specimens extracted from the manufactured mother plate.

stress-strain curve (cf. Fig. 18) is used in the inverse analysis leading to the elastic and our arbitrary or chosen limit values of shear strength and transverse strength matrix identifications (in red on Tabs. 2 and 3). For the other mechanical properties, the values given by the maker are considered to be reliable (in black on Tabs. 2 and 3).

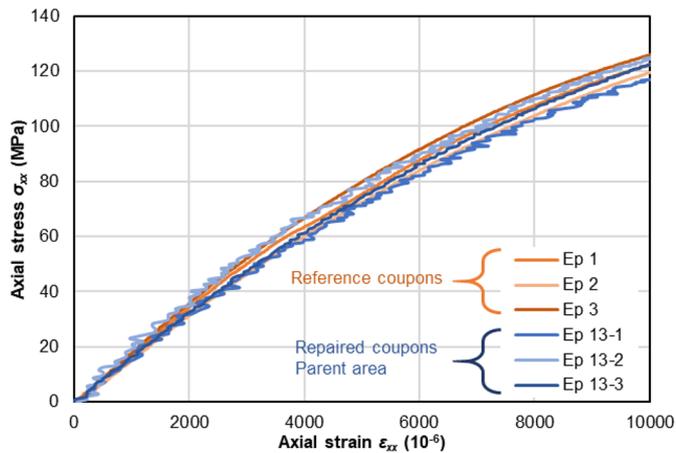
**Fig. 20.** Axial stress  $\sigma_{xx}$  – strain  $\epsilon_{xx}$  curve of the parent area of repair coupons Ep 13-1, 13-2 and 13-3 and reference test coupons Ep 1, 2 and 3.

down to zero. Comparing the test between the repaired composite specimens and the reference coupons, we cannot see any distinction in the mechanical behaviour (cf. Fig. 20). At this moment of the test, the adhesive has not reached a limit value.

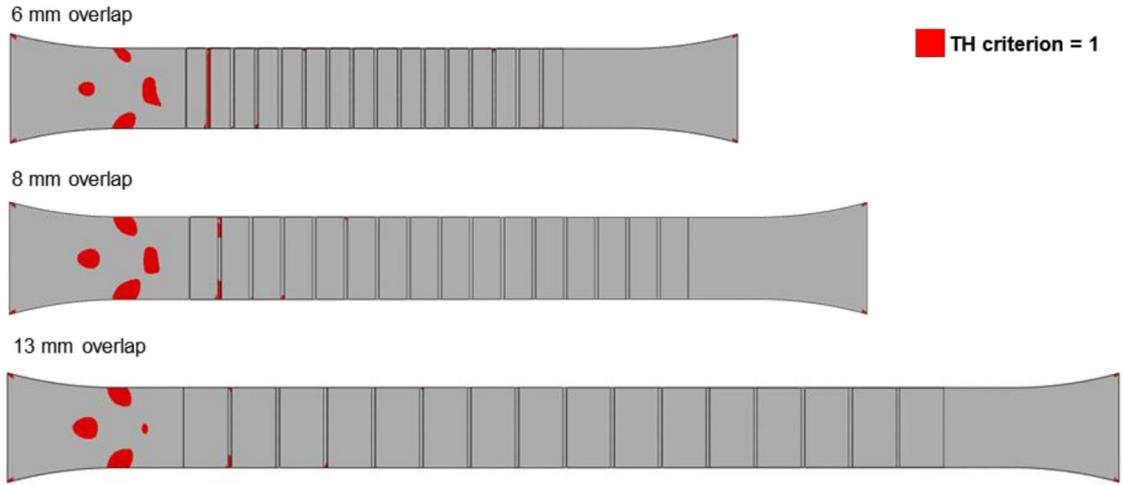
**Fig. 21.** Tsai-Hill criterion (TH = 1 in red when the chosen limit values are reached) in the FE models for the 6, 8 and 13 mm overlap lengths (from top to bottom).

As expected, the place where the limit values are reached is at the parent zone (with cross section reduction compared to the rest of the specimen) between the end tab and the overlap areas. It corresponds to the same situation in the reference coupons. The three overlap ratios exhibit numerically the same behaviour (cf. Fig. 21).

The FE results show that, at a load corresponding to the limit values in the parent composite (TH=1, cf. Fig. 21), the maximum shear value, calculated in the adhesive (area under the  $\tau_{xz}$  curve), is 13.5 MPa in both step #1 and step #16. The rest of the steps in between have a less significant value (cf. Fig. 24). All overlap lengths

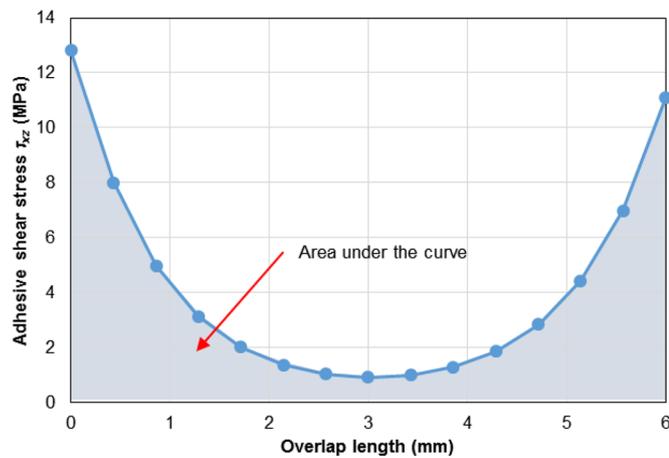
**Fig. 23.** Determination of the average shear value along the adhesive joint for 6 mm overlap length [7].

According to [7,11,12], a criterion to determine whether the bond has cohesively failed by shear stress is to obtain the area under the curve, which is the total stress per unit length that the adhesive carries (cf. Fig. 23). For epoxy adhesives, the shear strength, i.e. the maximum stress that can be applied into the adhesive along the overlap, is 35 MPa. Here, numerically the maximum shear stress was 13.5 MPa, which is indeed 2.5 times lower than the maximum shear stress for the adhesive. It was observed experimentally that no testing coupon had a failure of the adhesive.

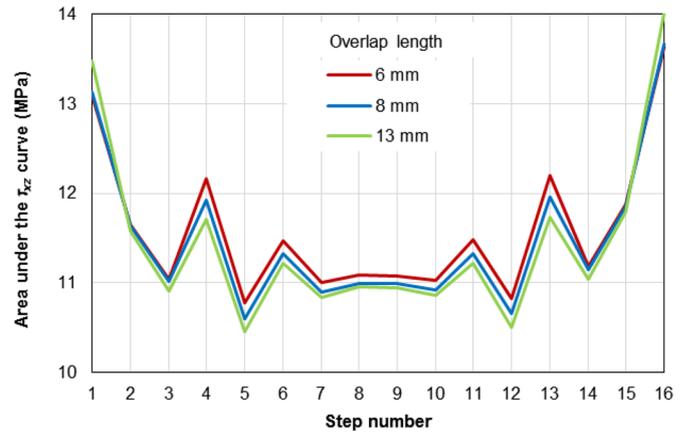
**Fig. 24.** Area under the curve  $\tau_{xz}$ -step length at each step and for the 6, 8 and 13 mm overlap lengths.
