Effect of marine environment on the behaviour of concrete structures reinforced by composite materials

Abstract. This study deals with experimental investigations of beam performances in a marine environment. Two kinds of concrete beams, unreinforced and reinforced with carbon plates and carbon rods, are being tested. The first one is stored in a laboratory, the other is exposed to a marine environment located in the north of France. After 12 months, all beams are tested via a four-point bending test in a laboratory. Results obtained have shown that beams stored in marine environment have a better behaviour than those stored in laboratory. It should be noted that no damage has occurred on these beams. However, we observe a significant increase of load of about 32% to 48% causing the first crack observed on the beams stored in marine environment compared to those stored in the laboratory. This means that beams in situ offer increased stiffness and a slight gain of failure loads. This may be due to the development of living organisms (in a marine environment) which acted as additional adhesive and sealing, providing a protection of concrete structures against damage.

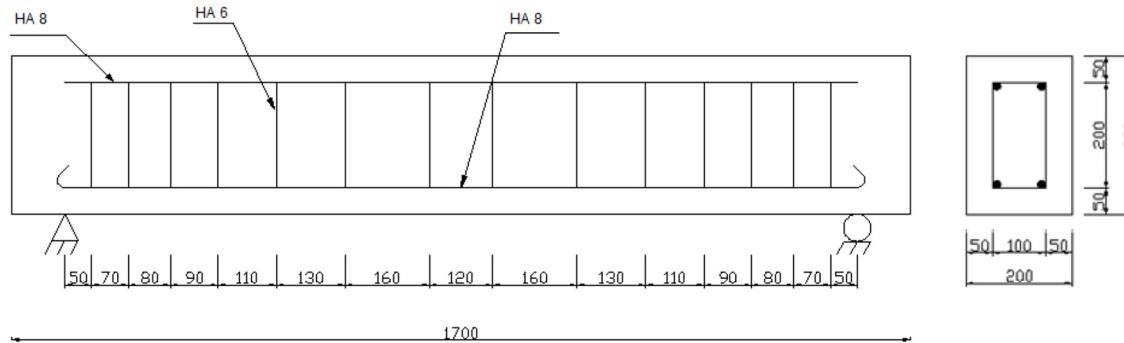
Fig. 1. Details of the beams reinforcement.

The reinforced concrete beams have 1700 mm length with a cross-section of 200 × 300 mm². The beams are reinforced with two longitudinal bars of 8 mm diameter at the bottom and top zones, and stirrups of 6 mm diameter (Fig. 1).

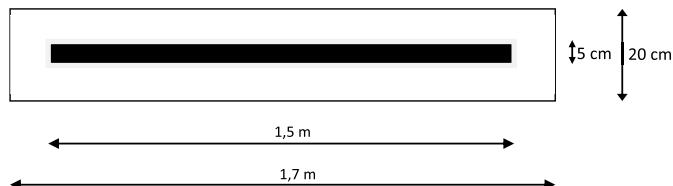
Fig. 2. Reinforcement with bonding of carbon plates.

In this study, two reinforced techniques are considered: reinforcement with carbon composite plates and reinforcement with carbon rods insertion. In the first technique, reinforced concrete was bonded with a carbon strip of 1.5 m length, 5 cm width and 1.2 mm thickness. The dimensions of concrete were 1.7 m length with a cross-section of 20 × 20 cm² (Fig. 2). The second technique used consisted of inserting two carbon rods in adhesive-prefilled concrete grooves. Carbon rods of 6 mm diameter are cut and degreased with a solvent before being placed in the grooves. Grooves must be filled with the extra glue and the surface must be levelled (Figs. 3, 4).

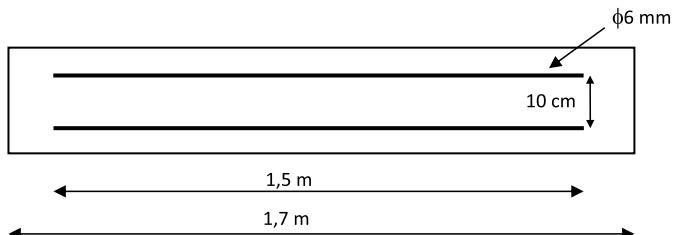
Fig. 3. Reinforcement with rods insertion.

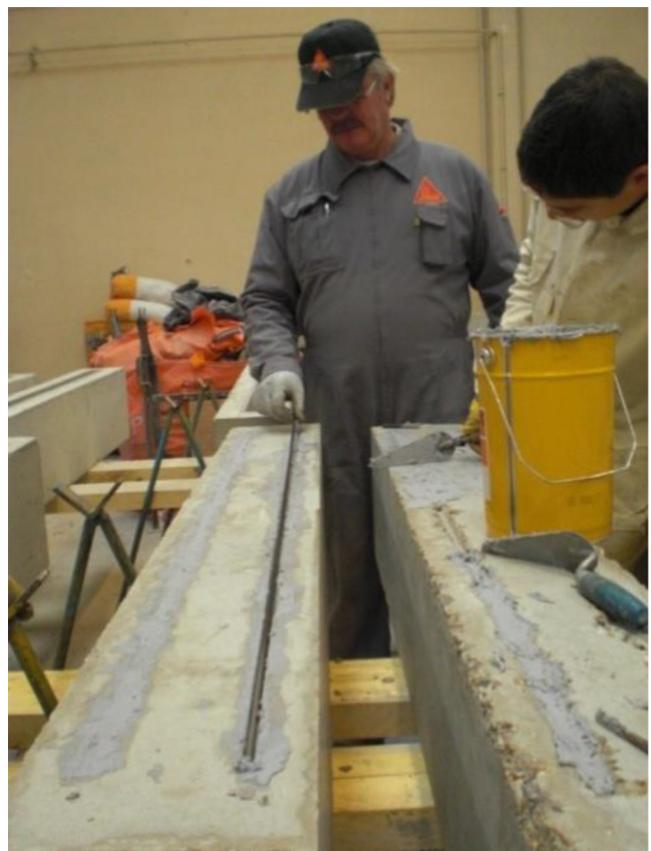
Fig. 4. Insertion of rods insertion.

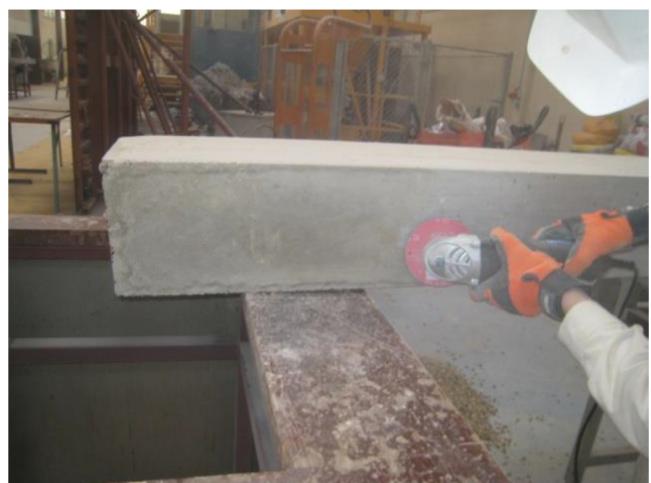
Fig. 5. Surface preparation.

The surface preparations are carried out in order to remove laitance, standing water, grease, oils, old surface treatments or coatings and all loosely adherent particles (Fig. 5). The surface to be strengthened must be prepared

by planing, grinding or sanding and dust must be removed by vacuum. This surface should be levelled and checked with a metal batten; the tolerance for 20 cm length is $\pm 2\text{mm}$. If this is not the case, repairs and levelling should be undertaken with structural repair materials such as repair mortar. Before applying adhesive, the substrate is thoroughly inspected and any unsound material (such as areas of damaged concrete or pieces of the original wooden formwork or tie-wires etc.) is removed. Adhesive is carefully applied to the properly cleaned and prepared substrate with a spatula to form a thin layer between 1.5 and 15 mm thick. Strips and rods are cleaned with a solvent dampened cloth before bonding. Carbon plate implementation is carried out using the double-application technique. A thin layer of adhesive is applied to concrete and plate. This double application allows an even coating of adhesive. The adhesive is applied at a temperature between 5 °C and 40 °C on a clean and healthy support with cohesive bond strength at least 1.5 MPa [23]. This adhesive is a 2-component thixotropic epoxy without solvents. It comes as a component A (white resin) and a component B (colour hardener black). Table 2 presents the mechanical characteristics of epoxy-based glue used to reinforce the test specimens. Using a rubber roller, the plate should be pressed in order to remove the excess adhesive (Figs. 6 and 7). The bonded surface should not be disturbed for at least 24 h and any vibrations should normally be kept at a minimum during the curing period of the adhesive. The strength of adhesive is reached after approximately 7 days at 20 °C.

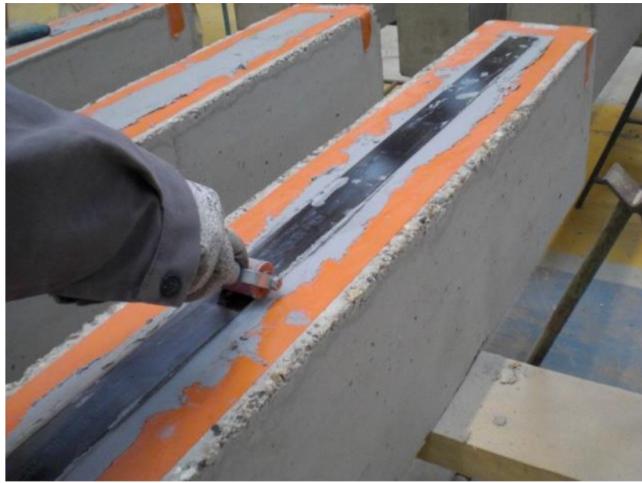
Fig. 6. Plate rubbing.

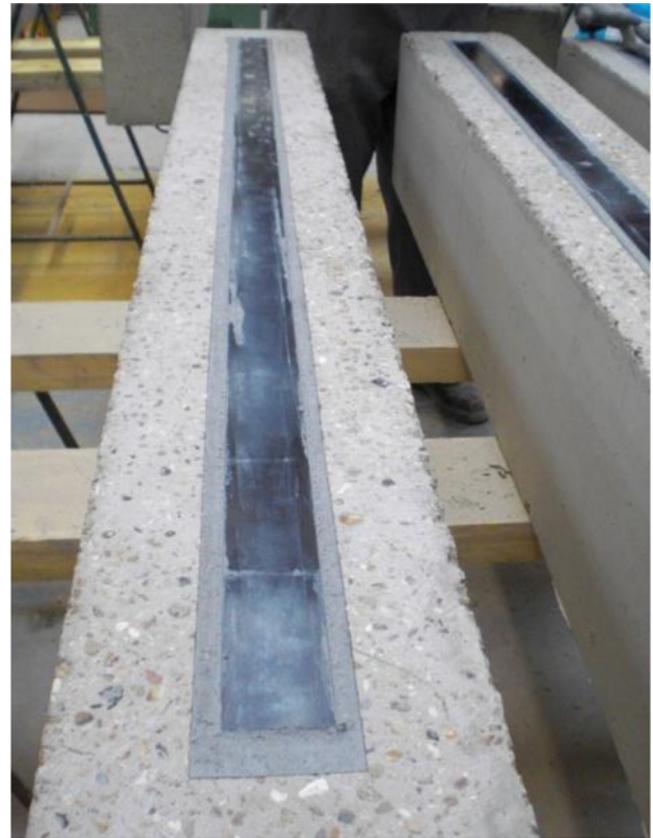
Fig. 7. Carbon plate reinforced beam.

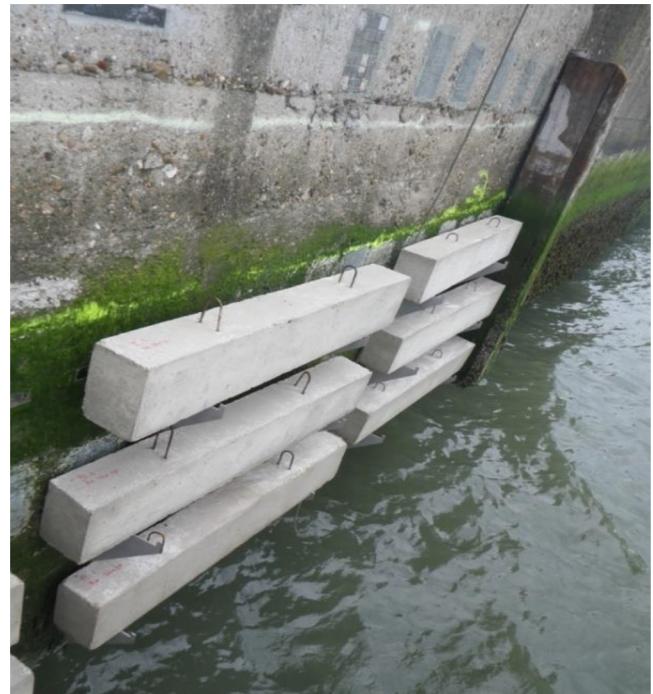
Fig. 8. Beams at the onset of ageing process.

Three beams of each series have been exposed in a drawdown zone to a marine environment for 12 months

(Fig. 8). At the end of this period, these beams and those stored in the laboratory are subjected to bending tests. The biological growths were removed with a scraper before

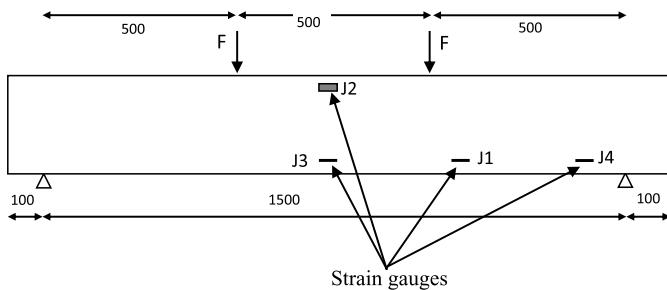
**Fig. 9.** Four-point bending test configuration.

Table 3 describes the type of beams, the storage conditions and the designation for bending tests. All beams were subjected to a four-point bending test with a 250 kN capacity press. The distance between the loading points is equal to 500 mm and the load point radius is equal to 0 m. Four displacement sensors were installed on both concrete and composite and were connected to a data acquisition system to measure displacements due to increasing load until failure (Fig. 9). The loading speed was held at a rate of 0.02 mm/s throughout the test.

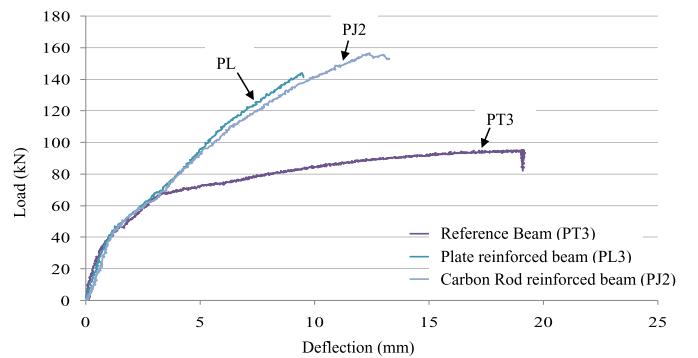
**Fig. 10.** Load /deflection curves of beams stored in laboratory.

Figure 10 presents the evolution of the applied load vs. displacement of bending tests. A comparison has been drawn between test results performed on reference and reinforced beams. For reinforced beams, it can be observed in Figure 10 two primary zones, namely:

- In the first zone, results show that behaviour is linear elastic with an absence of any cracked beams.

- In the second zone, a second linear phase corresponding to the behaviour of cracked beams. The composite material allows increasing the beam strength to compensate the delamination phenomenon produced between the concrete and steel reinforcement.

For the non-reinforced beams, the two first phases are identical up to reinforced beams, but a third phase appears which corresponds to plastic behaviour of beams. These results indicated that the reinforcement with composite materials increases failure load and decreases mid span displacement. Furthermore, the failure load increased by about 60% between carbon plate reinforced and reference beams and by about 75% between carbon rod reinforced and reference beams.

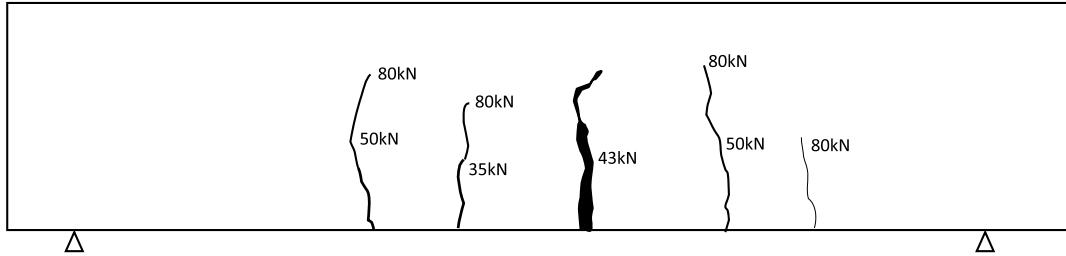
Fig. 11. Cracking of a reference beam stored in laboratory.

The formation of first cracks have been detected for a 35 kN load and located at mid span beam deflection of 0.86 mm. Cracks due to the bending moment increase gradually as the applied load increases and the direction of cracks is perpendicular to the beam's axis. Cracks are located in a constant bending moment zone and their opening values are between 3 and 5 mm (Fig. 11). For the carbon plate reinforced beams, initiation and propagation cracks are given in Figure 12. The load corresponding to the initiation of crack is 45 kN. The failure load gain is about 145 kN, which corresponds to 75% of gain compared to the failure load of PT4 reference beam (Fig. 11).

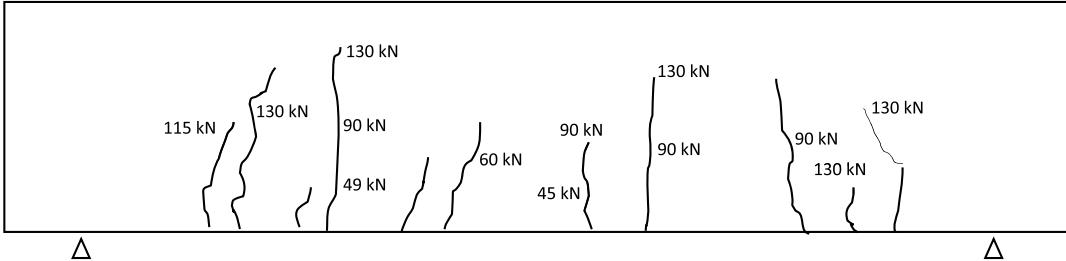
Fig. 12. Cracking of a plate reinforced beam stored in laboratory.

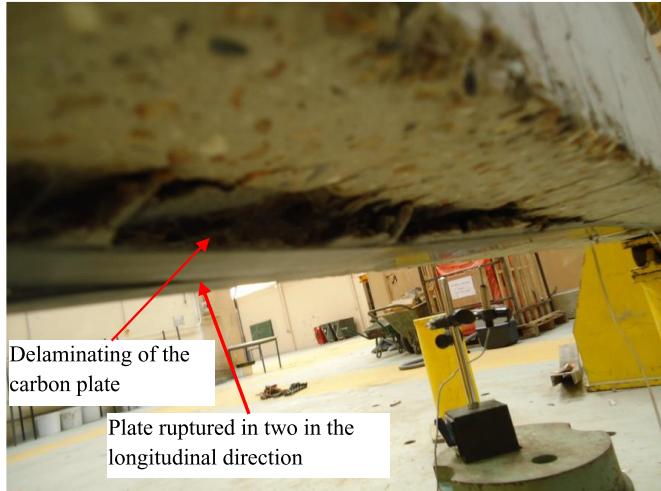
Fig. 13. Rupture of a carbon plate reinforced beam (PL3).

Figure 13 shows the fracture mode of a carbon plate reinforced beams. It can be observed that delamination occurs at the concrete/composite interface. The beam fracture was caused by peeling off [24]. This rupture mode is identical for three composite plates reinforced beams.

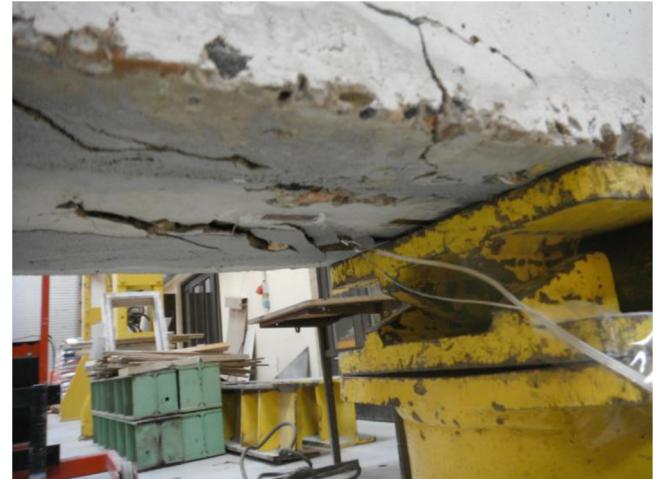
Fig. 14. Rupture of a carbon rod reinforced beam (PJ2).

In the case of beams reinforced with composite carbon rods, rupture is sudden demonstrating a high fragility of carbon-rod reinforced beams (Fig. 14). In Figure 15, the initiation of cracks corresponds to a load of 45 kN which is similar to the carbon plate reinforced beams. The failure load is equal to 170 kN corresponding to a load gain of 80% compared to the unreinforced beam. Cracks initiated at the two supports and between these propagate in the direction of the load application point.

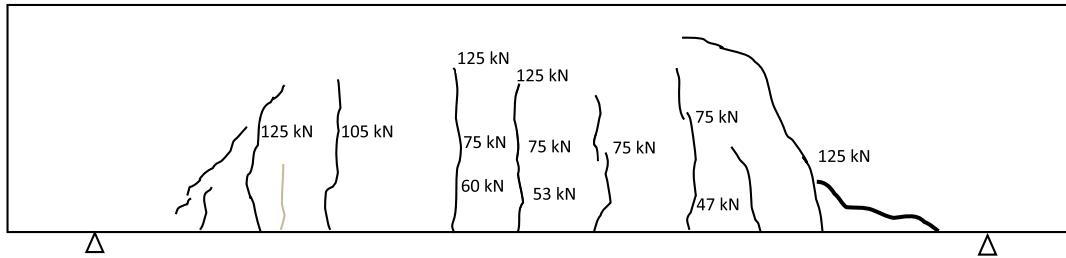
Fig. 15. Cracking of a rod reinforced beam stored in laboratory.

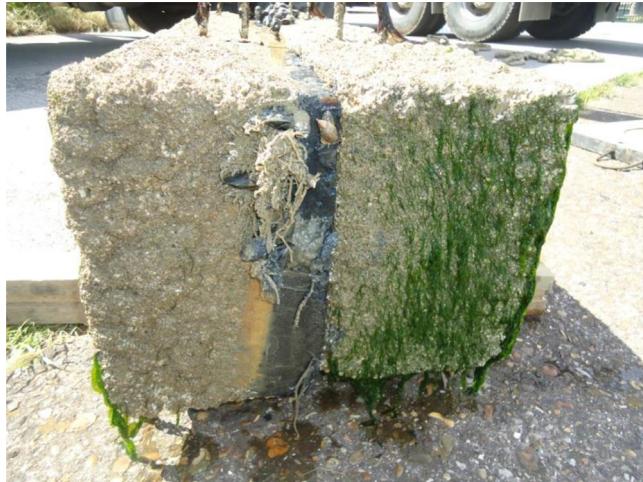
Fig. 16. Development of living organisms on the beams at the Port of Dunkerque.

drawdown zone of the port of Dunkerque located in the north of France. After 12 months of aging, significant biological substance was observed on all beam surfaces. These biological growths are barnacles, algae and molluscs (Fig. 16). A high density of these biological substances has also been observed along the edges of carbon plates, but not on these plate surfaces.

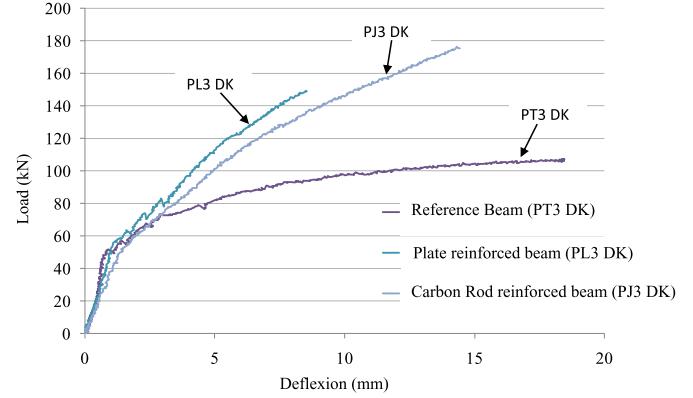
Fig. 17. Load/deflection curves of beams stored in situ (Port of Dunkerque).

Beams were tested via a four-point bending test in the same experimental conditions than those stored in the laboratory. Figure 17 shows the load evolution in function of the deflection. Failure load was equal to 85 kN for non-reinforced beams. The initiation of cracks was occurred similarly for two unreinforced beams. When the tensile stress reaches the concrete strength, one or more cracks appear. Increasing crack numbers were observed as well as

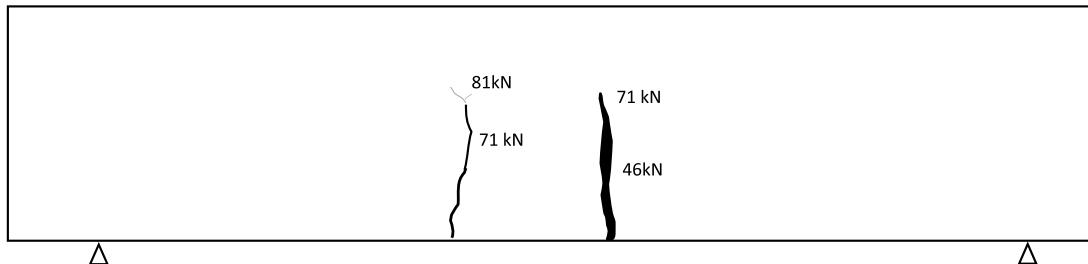
Fig. 18. Cracking of a reference beam stored in situ.

an increase in crack widths between 3 and 5 mm. These cracks propagate progressively according to the applied load in the direction of the upper face of beams (Fig. 18).

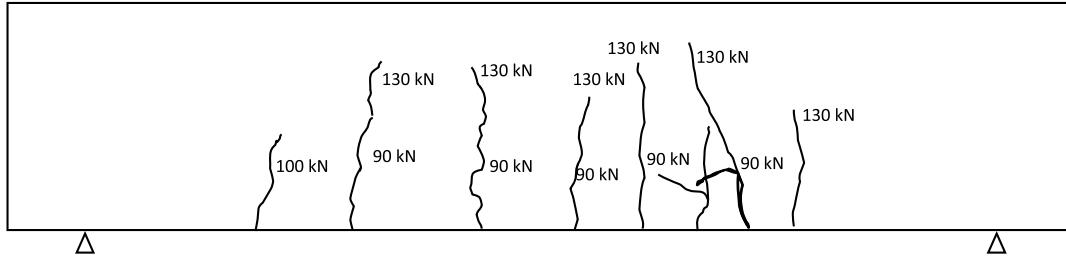
Fig. 19. Cracking of a plate-reinforced beam stored in situ (Port of Dunkerque).

For reinforced beams with a carbon-composite plate, a significant cracking occurs at 137 kN. Then, the load decreases according to the initiation of the first crack which is produced at 148 kN. The failure load gain is about 43%, it is lower than that of all beams stored in laboratory (Fig. 19).

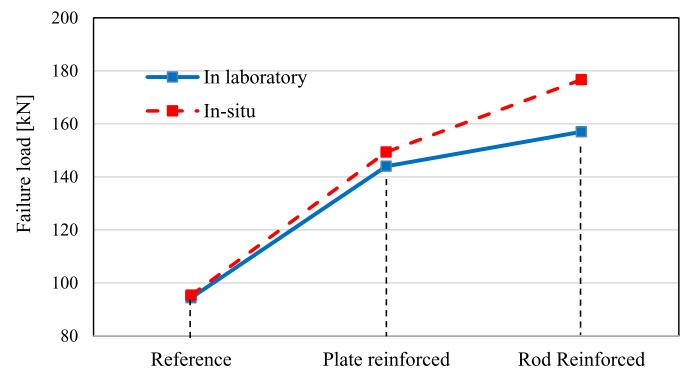
Fig. 21. Comparison of failure loads concerning beams in laboratory and in situ.

beams, carbon plate-reinforced and carbon rod-reinforced beams. Tests have been performed to characterise the mechanical behaviour and to predict the failure load. The comparison between beams stored in laboratory and those exposed to marine environment is presented in [Table 4](#) and [Figure 21](#). Load values are obtained by a simple average of all failure loads of three tested beams for each specimen category. The important points emerging from this study are:

- Beams exposed in marine environment have a failure load slightly higher than exposed in laboratory. This may be due to plasticization of the adhesive by water or the
